## Town of Clarksburg, Massachusetts

## Municipal Buildings

# Town Hall

## Town of Clarksburg ADA Transition Plan

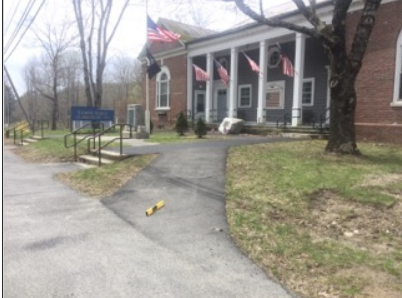
ID	Location	Floor	Room	Element	Type	Photo	Issues	Current Measure	Recommendations	Quantity	Price	Cost Estimation
<b>Approach and Entrance</b>												
<b>Exterior Access Route</b>												
1	River Road - Front Entrance	Exterior		Exterior Access Route	Walkway

Running slope > 1:20 (5%)	8.3%	Reduce running slope to be no steeper than 1:20 (5%).	1	-	\$0
<b>Off-Street Parking Lot or Garage</b>												
2	Parking Lot	Exterior		Off-Street Parking Lot or Garage	Visitor

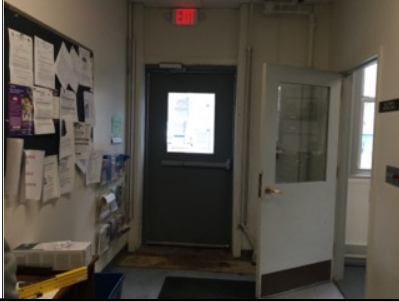
ID	Location	Floor	Room	Element	Type	Photo	Issues	Current Measure	Recommendations	Quantity	Price	Cost Estimation
10	Rear Entrance/ Exit	1		Means of Egress	N/A

Tactile exit sign not provided	-	Ensure a tactile exit sign with raised characters and braille is provided at exit door. Mount sign between 48"- 60" above the finished floor located on the latch side of the door.  After the change in level is fixed, provide an illuminated sign with the International Symbol of Accessibility (ISA). (See ID #6 and #13.)	1	232	\$232
<b>Interior Access Route</b>												
11	Towards Town Clerk	2		Interior Access Route	N/A

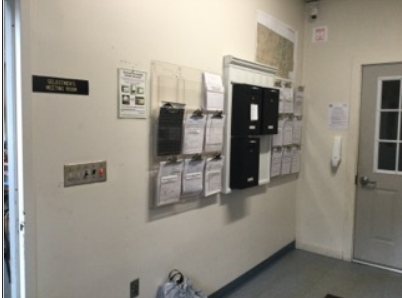
ID	Location	Floor	Room	Element	Type	Photo	Issues	Current Measure	Recommendations	Quantity	Price	Cost Estimation
<b>Operable Parts</b>												
30	Near the Administrative Assistant Office	1		Operable Parts	Other

Reach < 15" or > 48"(forward/side approach)	70.25"	Locate file wall holder 48" above the finished floor.	1	Labor	\$0
31	Near the Administrative Assistant Office	1		Operable Parts	Other

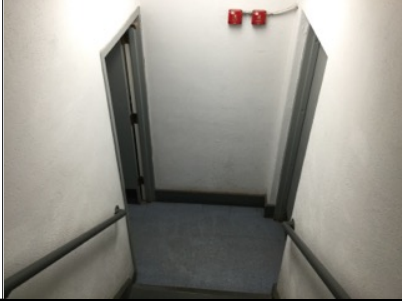
ID	Location	Floor	Room	Element	Type	Photo	Issues	Current Measure	Recommendations	Quantity	Price	Cost Estimation
<b>Signage</b>												
38	From 2nd Floor to 1st Floor	1		Signage	N/A

Recommend providing directional signs at this location.	1	-	\$0
<b>Stairs</b>												
39	From 1st to 2nd Floor	1		Stairs	N/A

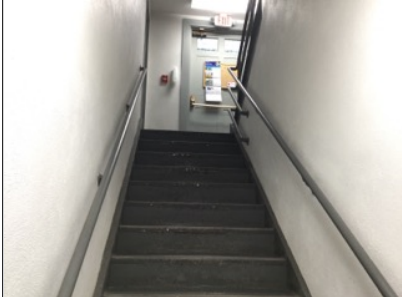
Recommend adding contrasting strips at the edge of each step at the stairs leading to the main entrance and the interior stairs.	1	-	\$0

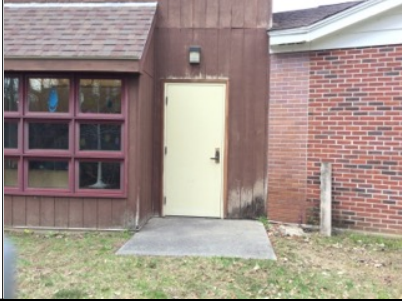
ID	Location	Floor	Room	Element	Type	Photo	Issues	Current Measure	Recommendations	Quantity	Price	Cost Estimation
<b>Emergency Exit</b>												
5	Exit - Near Computer Area	1		Emergency Exit	N/A

Clear floor space not provide outside the swing of the door	-	Provide a 30" x 48" clear floor space outside the swing of the door.  (Cost for a 3 ft. by 4 ft. concrete patch.)	1	192	\$192
<b>Access to Goods and Services</b>												
<b>Means of Egress</b>												
6	Exit - Near Computer Area	1		Means of Egress	N/A

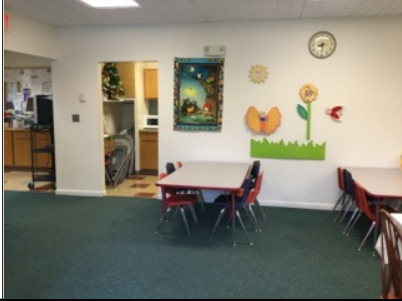
ID	Location	Floor	Room	Element	Type	Photo	Issues	Current Measure	Recommendations	Quantity	Price	Cost Estimation
<b>Dining or Work Surfaces</b>												
14	Children Section	1		Dining or Work Surfaces	Work Surface

Knee or toe clearance not provided Top of dining/work surface < 26" or > 30"	23" 24"	Adjust at least one work surface to ensure there is a 24" min. knee and toe clearance. Ensure that the top of at least one of the work surfaces is mounted between 26" - 30" above the finished floor.	1	Labor	\$0
<b>Kitchens and Kitchenettes</b>												
15	Kitchenette	1		Kitchens and Kitchenettes	N/A

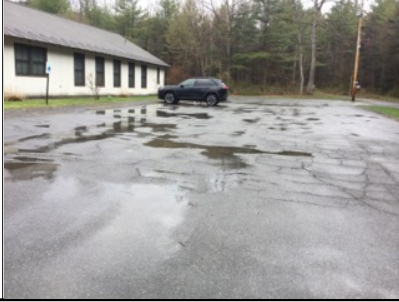
ID	Location	Floor	Room	Element	Type	Photo	Issues	Current Measure	Recommendations	Quantity	Price	Cost Estimation
6	Parking	Exterior		Off-Street Parking Lot or Garage	Visitor

Does not prevent accumulation of water	-	Repair surface.	1	-	\$0
<b>Entrance</b>												
7	Main Entrance/Exit	1		Entrance	Main Entrance

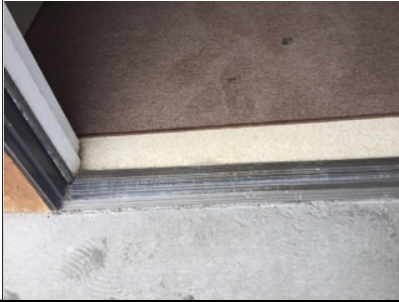
Threshold not beveled Threshold > 1/2" high	- 1"	Bevel the threshold. Alter threshold to be 1/2" high max.	1	150	\$150
8	Main Entrance	Exterior		Entrance	Main Entrance

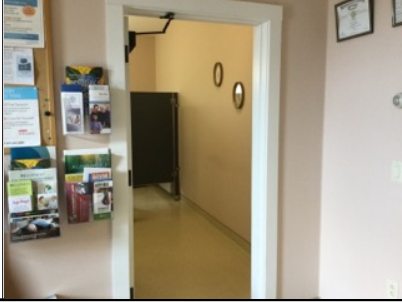
Door requires > 5 lbs. of force to open	20 lbs.	Adjust closers so doors do not require more than 5 pounds of force to open.	1	Labor	\$0
<b>Signage</b>												
17	Men's Toilet Room	1		Signage	Designation

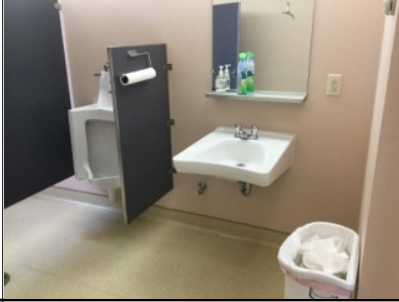
Toe or knee clearances not provided Plumbing underneath is exposed Mirror above lavatory w/reflective surface > 40"	25.25" - 42.25"	Provide a lavatory with knee and toe clearance positioned for a forward approach. Insulate or otherwise configure pipes to prevent contact for at lavatory. Lower mirror so that the bottom surface is at 40" max. above the finished floor.	1	1942	\$1942
22	Women's Toilet Room	1		Lavatory	N/A

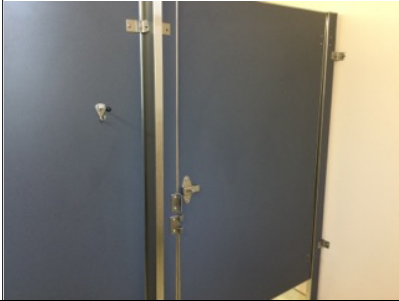
Door has malfunctioning self-closing hinge Door pull not provided		Repair hinge. Provide a door pull on both sides of the door near the latch.	1	70	\$70
24	Women's Toilet Room	1		Toilet Compartment	Accessible Compartment

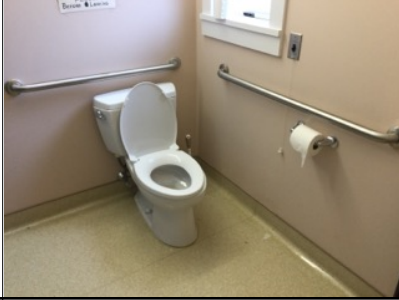
Rear grab bar < 42" long (MAAB)	-	Provide a rear wall grab bar that is 42" long min. and extends from the toilet 12" min. on one side and 24" min. on the other side (open side).	1	898	\$898
25	Men's Toilet Room	1		Toilet Compartment	Accessible Compartment

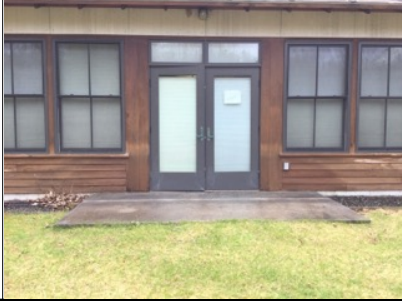
Recommend providing railing.	1	-	\$0
<b>Stove</b>												
32	Kitchen	1		Stove	N/A

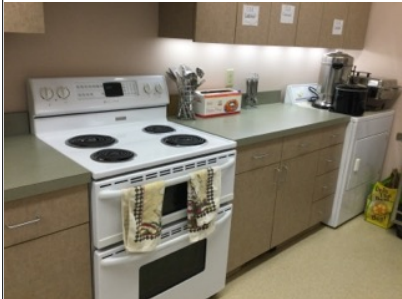
Recommend having a stove with controls located on the front.	1	-	\$0

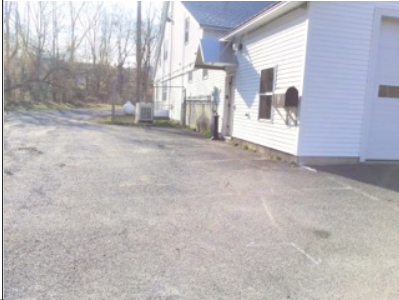
Obstructed by protruding objects	13.75%	Relocate mail box so it does not protrude into the circulation path.	1	Labor	\$0
2	Cross Road - Northeast Side	Exterior		Exterior Access Route	Exterior

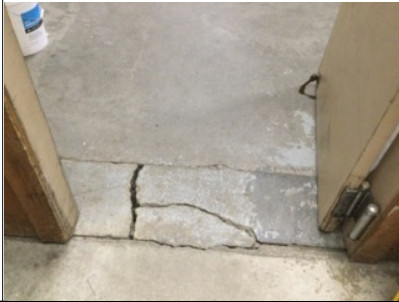
Not maintained in operable working condition		Repair threshold at door to ensure is maintain in operable working condition.	1	-	\$0
<b>Off-Street Parking Lot or Garage</b>												
4	Parking Lot (Back Side of Building)	Exterior		Off-Street Parking Lot or Garage	Visitor

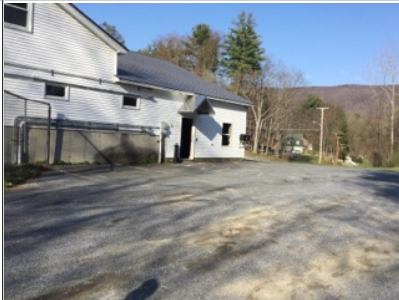
Total # of designated van accessible spaces	-	Provide a van accessible space that is at least 132" wide with a marked access aisle that is at least 60" wide. Provide a sign with the bottom of the sign 60" min. above the ground and the top 96" max. above the ground. Add the designation "Van Accessible" to the sign.	1	1100	\$1100

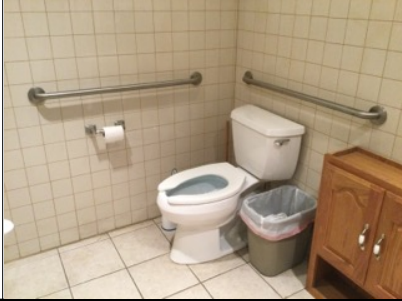
Clearance at toilet < 60" clear width Distance between toilet and nearest fixture < 42"	- 27"	Remove cabinet to maintain the required 60" wide min. clear floor space at the toilet. Remove urinal to provide the required 42" min. distance between the toilet and the nearest fixture. (Cost is to remove the urinal.)	1	580	\$580
<b>Urinal</b>												
16	Single-User Toilet Room	1		Urinal	N/A

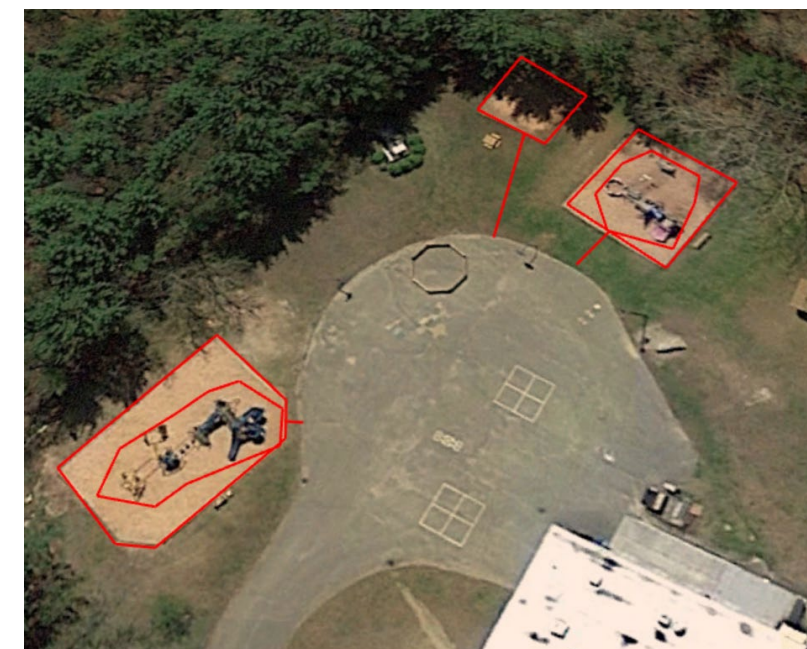
Fig. #1 Suggested route connecting the playgrounds.

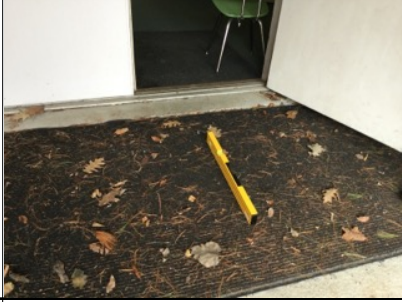
Threshold > 1/2" high	1"	Alter the threshold to be 1/2" high max.	1	150	\$150
12	Kindergarten	1	4	Emergency Exit	N/A

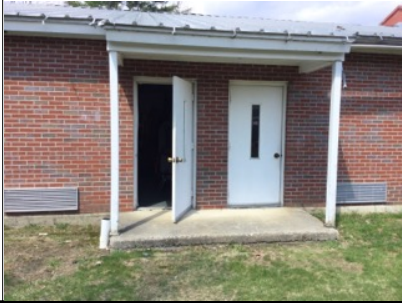
Provide a 30" by 48" clear floor space outside the swing of the door.  Note: Recommendation applies to all exit doors.	2	192	\$384
13	Exit - Grade 2	1	6	Emergency Exit	N/A	 	Threshold > 1/2" high Threshold not beveled	2.25" -	Alter the threshold to be 1/2" high max. Bevel the threshold.	1	300	\$300
14	Exit Near Lift Between Middle Wing and Junior High Wing	Exterior		Emergency Exit	N/A

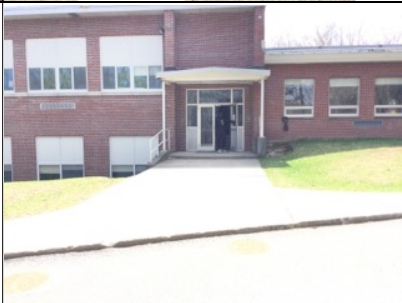
Door requires > 15 lbs. of force to open	15 lbs.	Adjust closer of exterior door so door does not require more than 15 pounds of force.	1	Labor	\$0
15	Exit - Grade 2	1	6	Emergency Exit	N/A

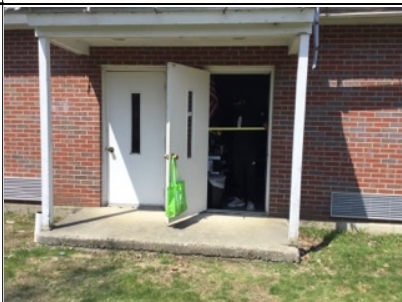
See ID #12 for recommendation and cost.	1	-	\$0

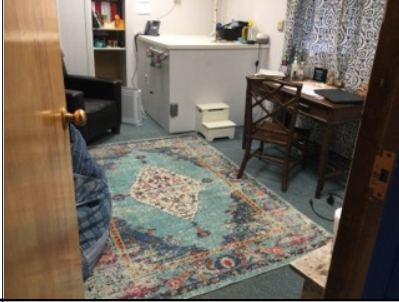
Surface not stable, firm, and slip-resistant	-	Ensure mat is securely attached to the floor.	1	Labor	\$0
27	Primary Wing	1		Interior Access Route	N/A

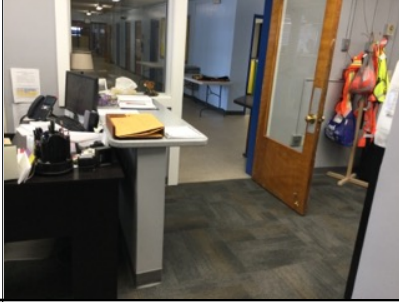
Maneuvering clearance(s) not provided Hardware not operable with a closed fist	11" -	Keep door open during business hours. Provide hardware that can be operable with one hand and not require tight grasping, pinching, or twisting of the wrist.	1	484	\$484
32	OT/PT/ Special Ed	1		Doors, Doorways, & Gates	Meeting Room

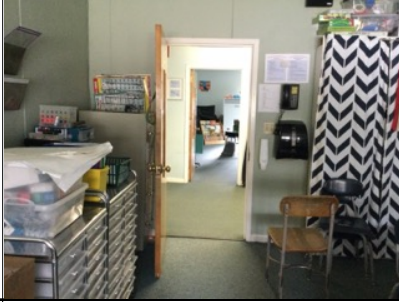
Maneuvering clearance(s) not provided Hardware not operable with a closed fist	- -	Remove chair to maintain the maneuvering clearance at the door. Provide hardware that can be operable with one hand and not require tight grasping, pinching, or twisting of the wrist.	1	484	\$484
37	Special Ed	1	5	Doors, Doorways, & Gates	Emergency Egress

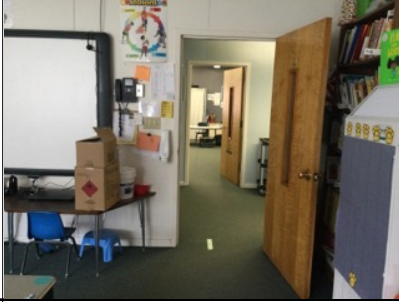
Maneuvering clearance(s) not provided Hardware not operable with a closed fist	- -	Relocate table to maintain the maneuvering clearance at the door. Provide hardware that can be operable with one hand and not require tight grasping, pinching, or twisting of the wrist.	1	484	\$484
42	Kindergarten	1	4	Doors, Doorways, & Gates	Emergency Egress

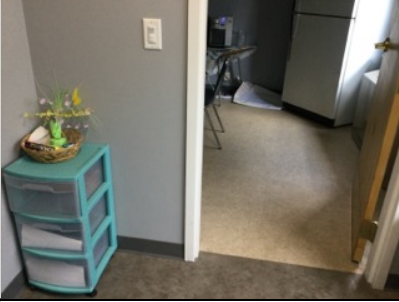
Maneuvering clearance(s) not provided	-	Relocate storage to maintain the maneuvering clearance at the door.	1	Labor	\$0
47	Nurse's Office	1	11	Doors, Doorways, & Gates	Office

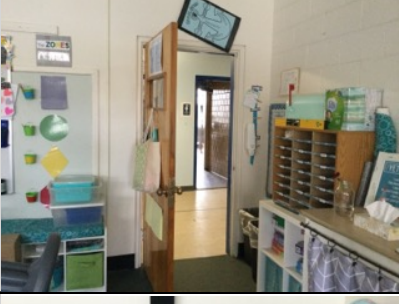
Maneuvering clearance(s) not provided Hardware not operable with a closed fist	- -	Relocate storage to maintain the maneuvering clearance at the door. Provide hardware that can be operable with one hand and not require tight grasping, pinching, or twisting of the wrist.  Recommendation applies to both doors.	1	484	\$484

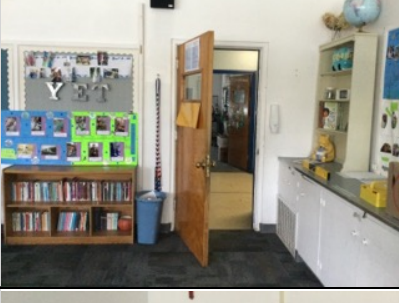
Maneuvering clearance(s) not provided Hardware not operable with a closed fist	- -	Remove cabinet to provide the required 18" min. maneuvering clearance at the door. Or have students use the second entrance/exit to the classroom. Provide hardware that can be operable with one hand and not require tight grasping, pinching, or twisting of the wrist.	1	484	\$484
50	Grade 4	1	14	Doors, Doorways, & Gates	Classroom

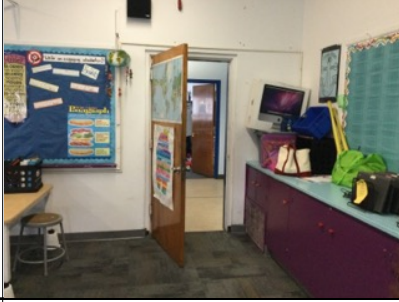
Maneuvering clearance(s) not provided Hardware not operable with a closed fist	-	Remove cabinet to provide the required 18" min. maneuvering clearance at the door. Or have students use the second entrance/exit to the classroom. Provide hardware that can be operable with one hand and not require tight grasping, pinching, or twisting of the wrist.	1	484	\$484
52	Grade 3	1	15	Doors, Doorways, & Gates	Classroom

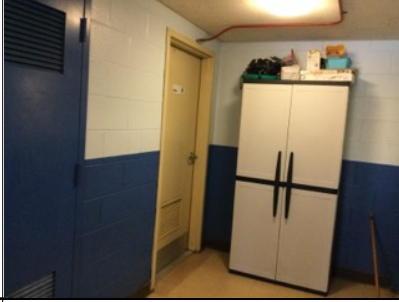
Maneuvering clearance(s) not provided	8"	Remove cabinet to maintain the required maneuvering clearance at the door.  (See ID #62 for additional information and cost.)	1	Labor	\$0
62	Women's Toilet Room	B		Doors, Doorways, & Gates	Toilet Room

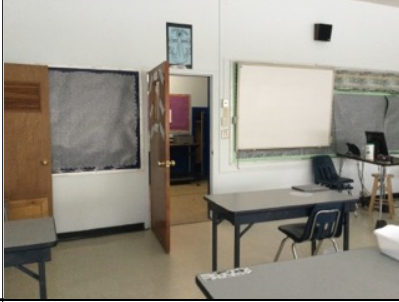
Hardware not operable with a closed fist	-	Provide hardware that can be operable with one hand and not require tight grasping, pinching, or twisting of the wrist.	1	484	\$484
67	Grade 6/ Math	1.5	16	Doors, Doorways, & Gates	Classroom

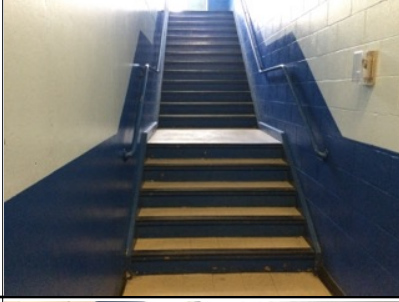
Handrails do not extend 12" from stairs	-	Top: Ensure handrails extend horizontally above the landing for 12" min. beginning above the first riser nosing. Bottom: Ensure handrails extend to one tread depth beyond the last riser.  Note: Recommendation applies to all stairs.	1	-	\$0

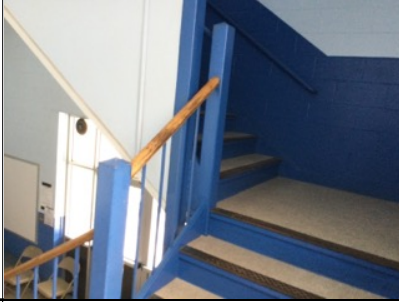
Handrails not continuous where required	-	Provide continuous handrails.  Note: Recommendation applies to all stairs.	1	-	\$0
72	Stair From Junior High Wing to Middle Wing	1.5		Stairways	Other

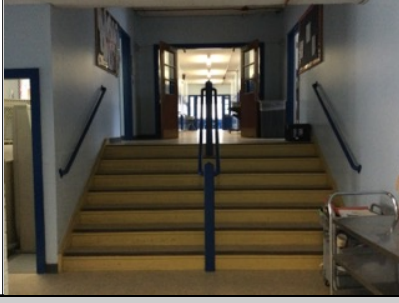
Handrails do not extend 12" from stairs	-	Top: Ensure handrails extend horizontally above the landing for 12" min. beginning above the first riser nosing. Bottom: Ensure handrails extend to one tread depth beyond the last riser.  Note: Recommendation applies to all stairs.	1	-	\$0
<b>Platform Lift or LULA Elevator</b>												
73	Lift Near Stair to Junior High Wing	1		Platform Lift or LULA Elevator	Interior

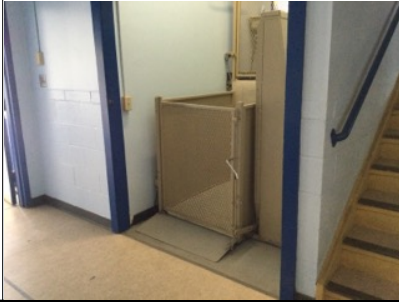
Not independently operable	-	Consider the installation of a LULA elevator.	1	90000	\$90000
74	Lift Near Stair to Junior High Wing	1		Platform Lift or LULA Elevator	Interior

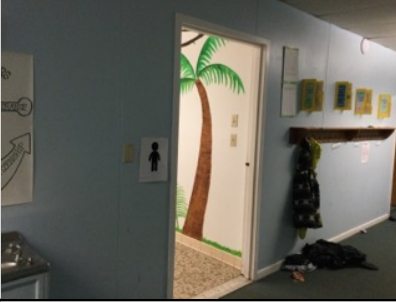
Raised characters not provided on sign Braille not provided on sign Sign not located on the latch side of the door	- - -	Provide text with raised characters duplicated in braille on sign. Locate sign alongside the door on the latch side.	1	232	\$232
77	Boys' Toilet Room	1		Signage	Designation

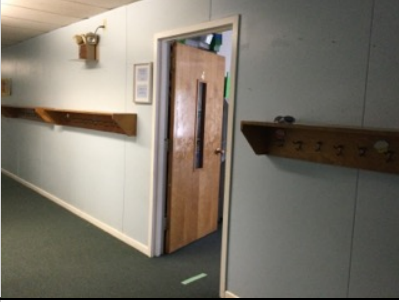
Raised characters not provided on sign Braille not provided on sign Sign not located on the latch side of the door	- - -	Provide text with raised characters duplicated in braille on sign. Locate sign alongside the door on the latch side.	1	232	\$232
82	OT/PT/ Special Ed	1	9	Signage	Designation

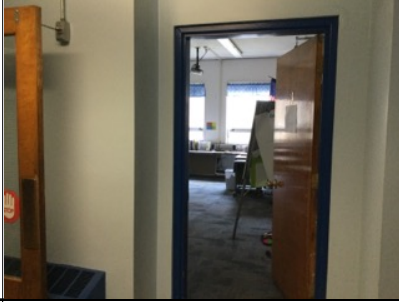
Raised characters not provided on sign Braille not provided on sign Sign not located on the latch side of the door	- - -	Provide text with raised characters duplicated in braille on sign. Locate sign at permanent rooms alongside the door on the latch side.	1	232	\$232
87	Grade 5	1	13	Signage	Designation

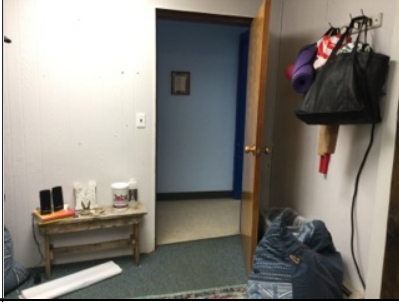
Reach < 15" or > 48"(forward/side approach)	-	Locate one hook 48" max. above the finished floor.	1	Labor	\$0
97	Grade 6/ Science	1.5	18	Operable Parts	Other

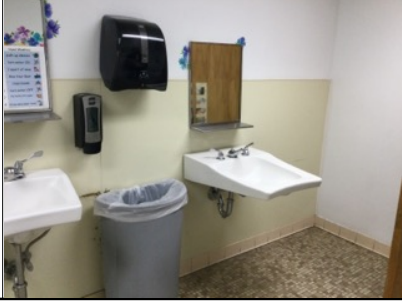
Plumbing underneath is exposed	-	Insulate or otherwise configure pipes to prevent contact for at least one lavatory.	1	92	\$92
<b>Single-User Toilet</b>												
117	Men's Toilet Room	B		Single-User Toilet	N/A

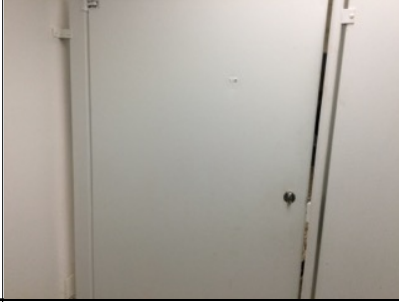
Door with malfunctioning self-closing hinge Door pull not provided	- -	Repair self-closing hinge. Provide a door pull on both sides of the door near the latch.	1	70	\$70
121	Girls' Toilet Room	1		Toilet Compartment (Children)	Accessible Compartment

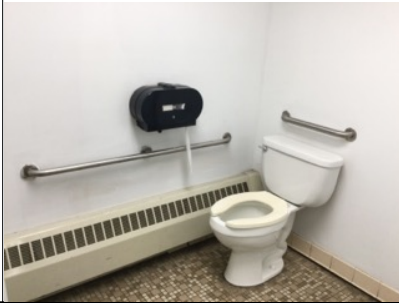
Side or rear grab bar < 42" long Flush control not on open side Non-compliant toilet paper dispenser	- - -	Provide a rear wall grab bar that is 42" long located 6" max. from the interior corner. Provide the flush control on the open side of the toilet (transfer side), no higher than 44". Relocate toilet paper dispenser so that it is between 14"- 19" above the floor and between 7"- 9" in front of the toilet. Ensure dispensers and other devices are not mounted above grab bars.	1	1528	\$1528

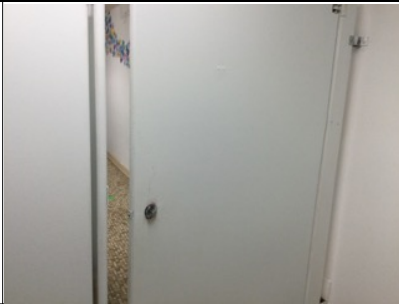
Door with malfunctioning self-closing hinge Door pull not provided	- -	Repair self-closing hinge. Provide a door pull on both sides of the door near the latch.	1	70	\$70
<b>Lavatory (Children)</b>												
123	Boys' Toilet Room	1		Lavatory (Children)	N/A

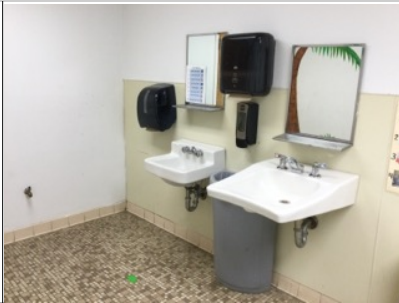
Faucet not operable with a closed fist Exposed plumbing underneath Mirror above lavatory w/reflective surface > 31"	- - 46"	Provide a faucet that can be operable with one hand and not require tight grasping, pinching or twisting of the wrist for at least one lavatory. Insulate or otherwise configure pipes to prevent contact, for at least one lavatory. Lower mirror so that the bottom surface is at 31" above finished floor.	1	1334	\$1334
<b>Additional Access</b>												
<b>Drinking Fountains</b>												
124	Near Boys' and Girls' Toilet Rooms - Primary Wing	1		Drinking Fountains	Low

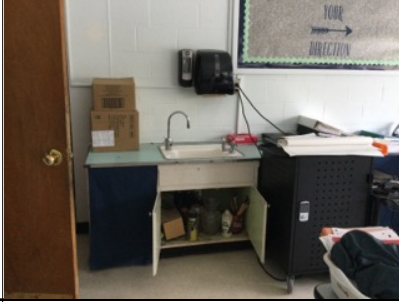
Toe and knee clearances not provided	-	Ensure there is a 27" knee clearance positioned for a forward approach.	1	1686	\$1686
136	Grade 7/ ELA	1.5	17	Sink	Classroom

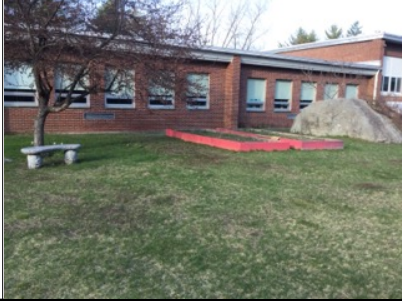
Recommend providing a planter with knee clearance positioned for a forward approach (deck).	1	-	\$0
<b>Examination Table</b>												
146	Nurse's Office	1	11	Examination Table	N/A

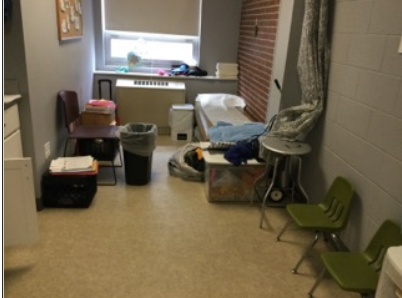
Recommend providing an adjustable examination table.	1	-	\$0
<b>Off-Street Parking Lot</b>												
147	Playground Outside Gym Entrance/Exit	B		Off-Street Parking Lot	N/A

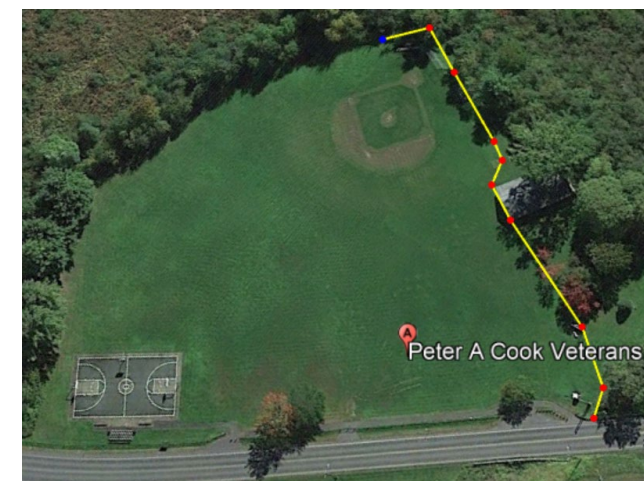
Image 1: Propose 48" wide minimum path.

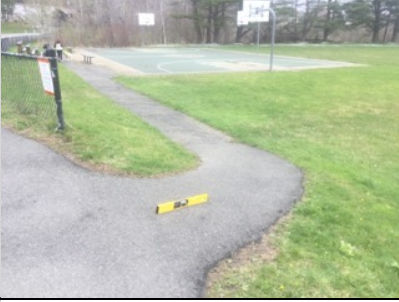
Running slope > 1:20 (5%)	14%	Reduce running slope to be no steeper than 1:20 (5%).  (Cost for adding concrete to correct pathway cross slope.)	1	4840	\$4840
7	Pavilion	Exterior		Exterior Access Route

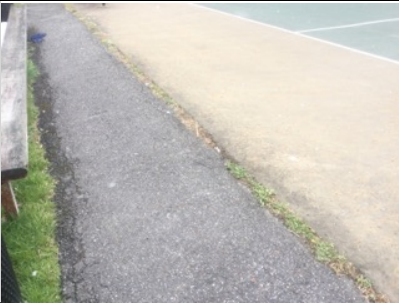
Route not maintained in operable working condition	-	Ensure the accessible route is maintained in operable working condition.	1	Labor	\$0
9	Trail Near Pavilion	Exterior		Exterior Access Route	Exterior

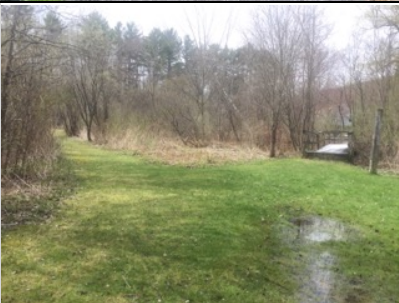
Route not maintained in operable working condition	-	Ensure the accessible route is maintained in operable working condition.	1	Labor	\$0

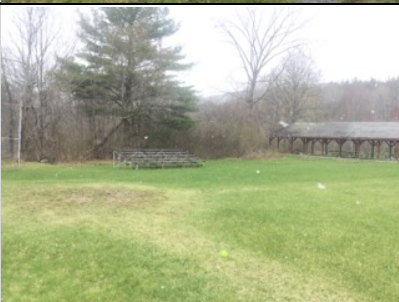
Accessible route not provided	-	Ensure an accessible route is provided.  (See ID #13 for cost.)	1	-	\$0

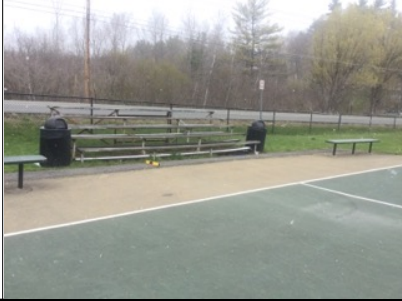
Accessible spaces are not provided at sidelines seating	-	Provide a 36" x 48" clear floor space at sidelines seating.	1	256	\$256
22	Bleacher Near Baseball	Exterior		Bleachers	N/A

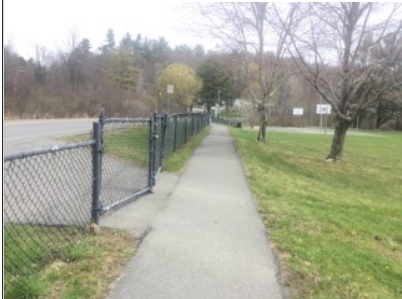
Recommend keeping this gate unlocked since this is the closest route to the basketball court. Recommend providing a 10" high solid surface (kick plate) on the push side of the gate.	1	-	\$0
<b>Railing</b>												
24	Pavilion	Exterior		Railing	N/A

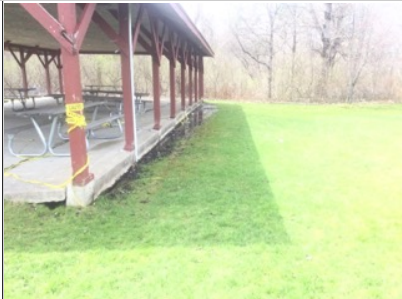
-	Until pavilion is fixed, recommend providing a railing to prevent tripping hazards. To keep wheelchair casters and crutch tips on the surface recommend providing edge protection by providing curbs, barriers, or extended surfaces.	1	-	\$0
