## Town of Clarksburg, Massachusetts

## Municipal Buildings

# Town Hall

## Town of Clarksburg ADA Transition Plan

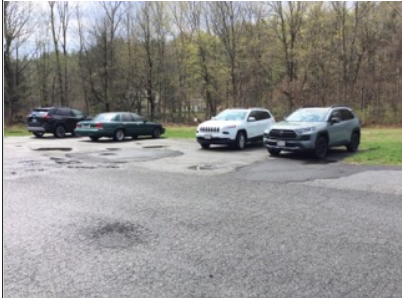
Total # of designated accessible parking spaces	-	Provide a van accessible space that is at least 132" wide with a marked access aisle that is at least 60" wide. Provide a sign with the bottom of the sign 60" min. above the ground and the top 96" max. above the ground. Add the designation "Van Accessible" to the sign.	1	1850	\$1850
<b>Entrance</b>												
3	To Rear Entrance - South Side	Exterior		Entrance	Other

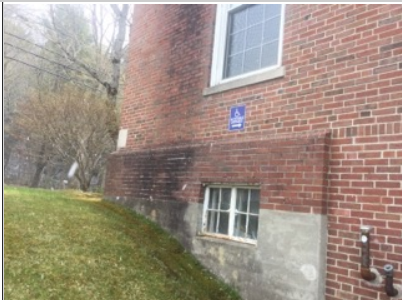
Locate directional sign at the inaccessible entrance.  (See ID #4.)	1	Labor	\$0

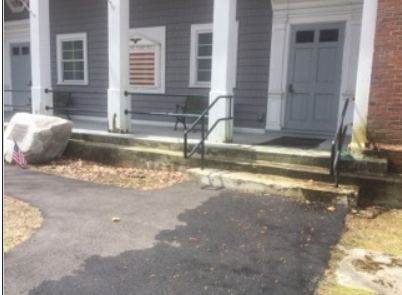
4	River Road - Front Entrance	Exterior		Entrance	N/A

Entrance not on an accessible route Directional sign to accessible entrance not provided	- -	Provide a directional sign indicating the location of the nearest accessible entrance.	1	346	\$346

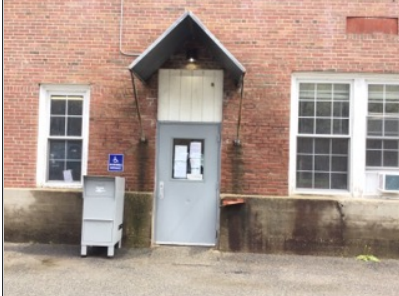
ID	Location	Floor	Room	Element	Type	Photo	Issues	Current Measure	Recommendations	Quantity	Price	Cost Estimation
5	Rear Entrance/ Exit	Exterior		Entrance	Secondary Entrance

Maneuvering clearance is not provided	-	Remove drop box to maintain the maneuvering clearance at the door.  (See ID #14 for additional recommendations.)	1	Labor	\$0
6	Rear Entrance/ Exit	Exterior		Entrance	Other

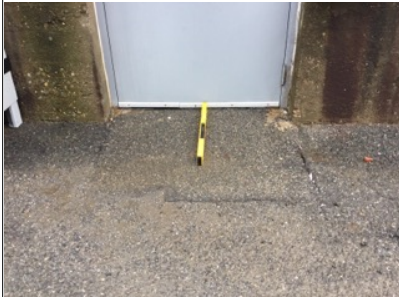
Maneuvering clearance at door > 1:50 (2.00%)	10.6%	Alter so that the slope in all directions is no greater than 1:50 (2.00%).  (See ID #14 for additional recommendations.)	1	200	\$200
<b>Access to Goods and Services</b>												
<b>Means of Egress</b>												
7	Front Entrance/ Exit	1.5		Means of Egress	N/A

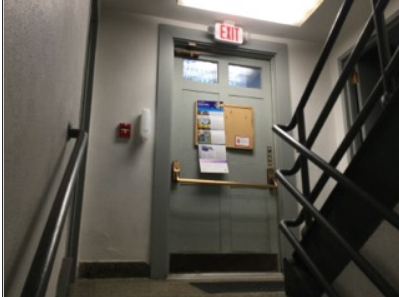
Tactile exit sign not provided	-	Ensure a tactile exit sign with raised characters and braille is provided at exit door. Mount sign between 48"- 60" above the finished floor located on the latch side of the door. Provide a directional sign to the accessible exit.	2	232	\$464

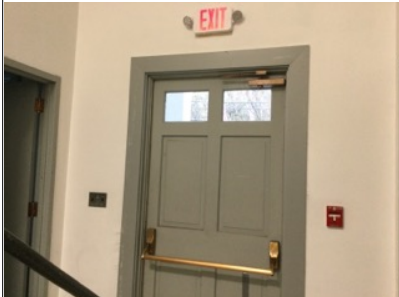
8	Exit Near the Historical Society	1.5		Means of Egress	N/A

Tactile exit sign not provided	-	Ensure tactile exit signs with raised characters and braille are provided at exit doors. Mount signs between 48"- 60" above the finished floor located on the latch side of the door. Provide a directional sign to the accessible exit.	1	464	\$464
9	Exit - Historical Society	1.5		Means of Egress	N/A

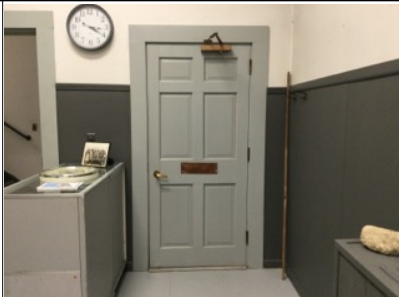
Tactile exit sign not provided	-	Ensure a tactile exit signs with raised characters and braille is provided at exit door. Mount sign between 48"- 60" above the finished floor located on the latch side of the door.	1	232	\$232

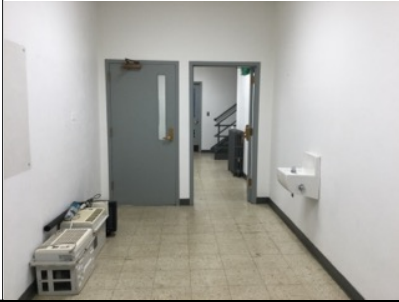
Obstructed by protruding objects	12.5"	Provide a cane-detectable barrier under the drinking fountain so it does not protrude into the circulation path.	1	878	\$878
12	From 1st Floor to 2nd Floor.	1		Interior Access Route	N/A

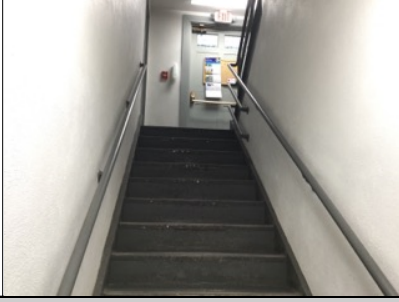
Accessible route not provided	-	Provide a LULA elevator that connects all levels in the Town Hall.	1	90000	\$90000

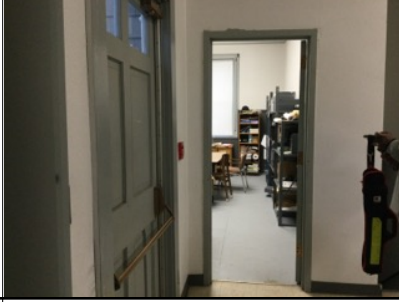
<b>Doors, Doorways, &amp; Gates</b>												
13	Historical Society	1.5		Doors, Doorways, & Gates	Office

Clear width at door < 32"	29.5"	Widen the door so that there is 32" min. clear width.	1	3366	\$3366
14	Rear Entrance/ Exit	1		Doors, Doorways, & Gates	N/A

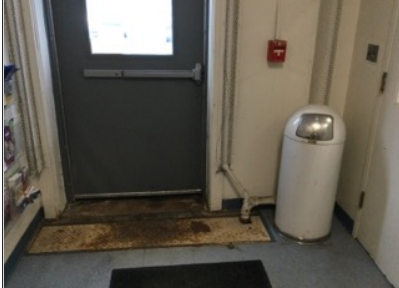
Maneuvering clearance(s) not provided	-	Provide an automatic door opener. Locate automatic door opener outside the swing of the door.	1	3060	\$3060

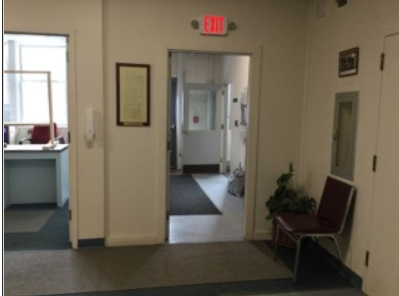
ID	Location	Floor	Room	Element	Type	Photo	Issues	Current Measure	Recommendations	Quantity	Price	Cost Estimation
15	To Main Entrance From Lobby	1		Doors, Doorways, & Gates	Circulation

Maneuvering clearance(s) not provided	-	Remove chair to maintain the required maneuvering clearance at the door.	1	Labor	\$0
16	Historical Society	1.5		Doors, Doorways, & Gates	N/A

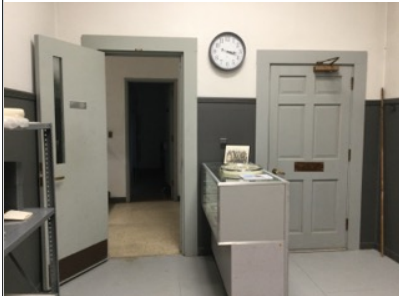
Maneuvering clearance(s) not provided	-	Relocate the display to maintain the maneuvering clearance at both doors.	1	Labor	\$0
17	Single-User Toilet Room	1		Doors, Doorways, & Gates	Toilet Room

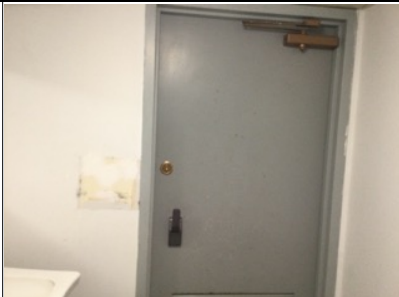
Door requires > 5 lbs. of force to open	16 lbs.	Adjust closers so doors do not require more than 5 pounds of force to open.	1	Labor	\$0
18	To Town Offices	1		Doors, Doorways, & Gates	Office

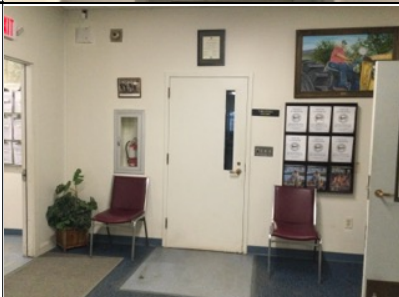
Door requires > 5 lbs. of force to open	11 lbs.	Adjust closers so doors do not require more than 5 pounds of force to open.	1	Labor	\$0
19	To Town Clerk Office	2		Doors, Doorways, & Gates	Office

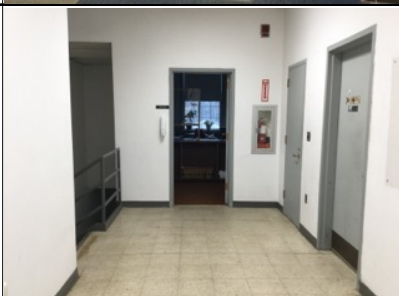
Door requires > 5 lbs. of force to open	11 lbs.	Adjust closer so door does not require more than 5 pounds of force to open.	1	Labor	\$0

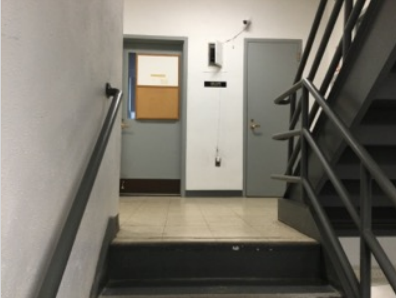
ID	Location	Floor	Room	Element	Type	Photo	Issues	Current Measure	Recommendations	Quantity	Price	Cost Estimation
<b>Stairways</b>												
20	Near Town Offices	1.5		Stairways	Egress

Handrails do not extend 12" from stairs	-	Top: Ensure handrails extend horizontally above the landing for 12" min. beginning above the first riser nosing. Bottom: Ensure handrails extend to one tread depth beyond the last riser.	1	-	\$0
21	Near Town Offices	2		Stairways	Egress

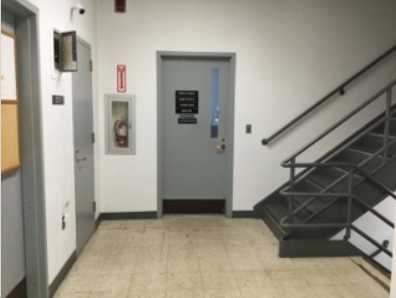
Handrails do not extend 12" from stairs	-	Top: Ensure handrails extend horizontally above the landing for 12" min. beginning above the first riser nosing. Bottom: Ensure handrails extend to one tread depth beyond the last riser.	1	-	\$0
<b>Signage</b>												
22	Administrative Assistant Office	1		Signage	Designation

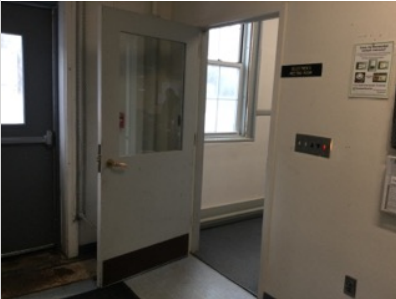
Raised characters not provided on sign Raised characters < 48" or > 60" above ground Braille not provided on sign	- - -	Provide text with raised characters duplicated in braille on sign. Mount sign so that the baseline of the lowest tactile character is 48" min. above finished floor and the baseline of the highest tactile character is 60" max. above the finished floor.	1	232	\$232

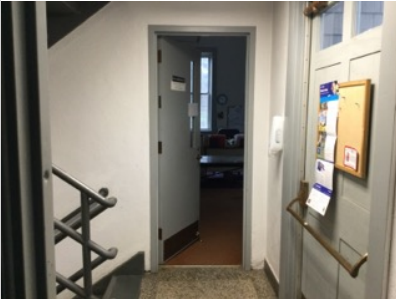
23	Town Administrator Office	1.5		Signage	Designation

Raised characters not provided on sign Raised characters < 48" or > 60" above ground Braille not provided on sign Sign not located on the latch side of the door	- - - -	Provide text with raised characters duplicated in braille on sign. Mount sign so that the baseline of the lowest tactile character is 48" min. above finished floor and the baseline of the highest tactile character is 60" max. above the finished floor. Locate sign at permanent rooms alongside the door on the latch side.	1	232	\$232
24	Town Clerk Office	2		Signage	Designation

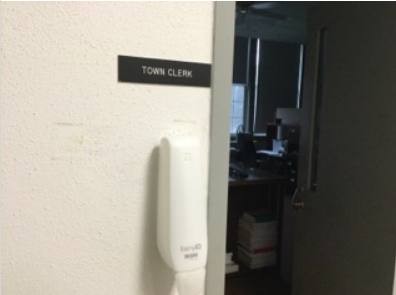
Raised characters not provided on sign Raised characters < 48" or > 60" above ground Braille not provided on sign	- 61.75" -	Provide text with raised characters duplicated in braille on sign. Mount sign so that the baseline of the lowest tactile character is 48" min. above finished floor and the baseline of the highest tactile character is 60" max. above the finished floor.	1	232	\$232

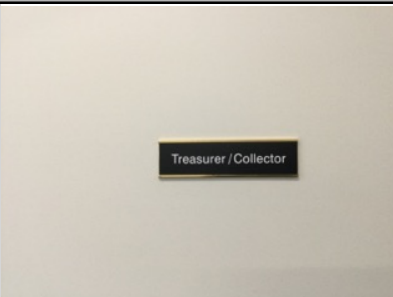
ID	Location	Floor	Room	Element	Type	Photo	Issues	Current Measure	Recommendations	Quantity	Price	Cost Estimation
25	Treasurer/Collector Office	1		Signage	Designation

Raised characters not provided on sign Braille not provided on sign Sign not located on the latch side of the door	- - -	Provide text with raised characters duplicated in braille on sign. Locate sign at permanent rooms alongside the door on the latch side.	1	232	\$232
26	Single-User Toilet Room	1		Signage	Designation

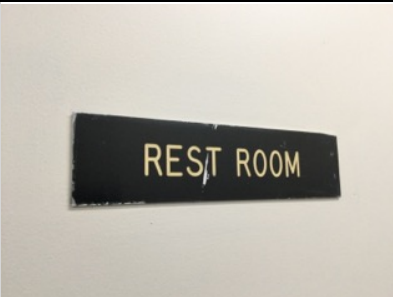
Raised characters not provided on sign Braille not provided on sign Sign not located on the latch side of the door	- - -	Provide text with raised characters duplicated in braille on sign. Locate sign at permanent rooms alongside the door on the latch side.	1	232	\$232
27	Men's Toilet Room (Staff Only)	1.5		Signage	Designation

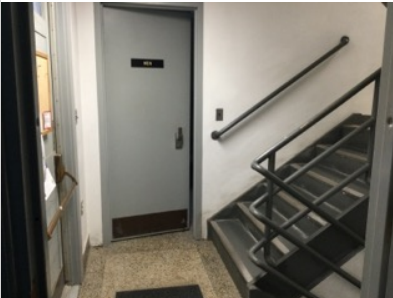
Raised characters not provided on sign Braille not provided on sign Sign not located on the latch side of the door	- - -	Provide text with raised characters duplicated in braille on sign. Locate sign at permanent rooms alongside the door on the latch side.	1	232	\$232

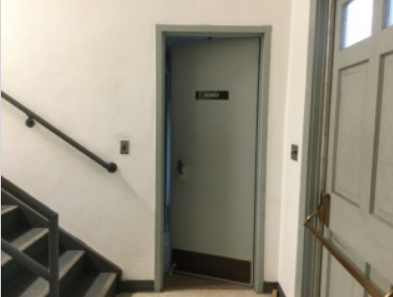
28	Women's Toilet Room (Staff Only)	1.5		Signage	Designation

Raised characters not provided on sign Braille not provided on sign Sign not located on the latch side of the door	- - -	Provide text with raised characters duplicated in braille on sign. Locate sign at permanent rooms alongside the door on the latch side.	1	232	\$232
<b>Service Counter</b>												
29	Treasurer/Collector Office	1		Service Counter	N/A

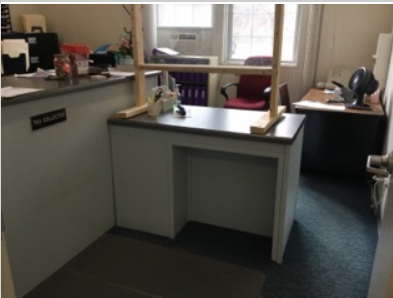
Counter > 36" high	43.25"	Provide a counter that is 36" max. above the finished floor.	1	880	\$880

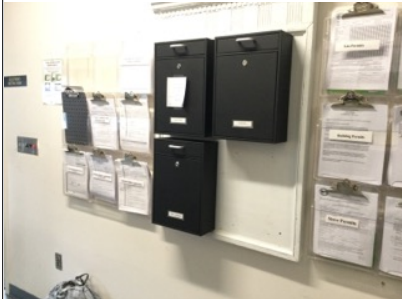
Reach < 15" or > 48"(forward/side approach)	69.75"	Locate mail boxes 48" above the finished floor.	1	Labor	\$0
<b>Toilet &amp; Bathing Rooms</b>												
<b>Lavatory</b>												
32	Single-User Toilet Room	1		Lavatory	N/A

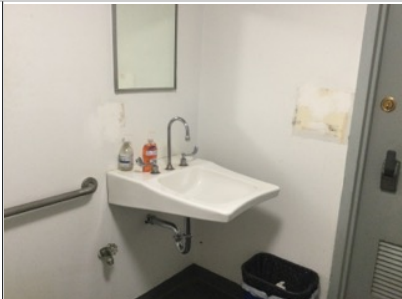
Plumbing underneath is exposed Mirror above lavatory w/reflective surface > 40"	- 50.25"	Insulate or otherwise configure pipes to prevent contact for at least one lavatory. Lower mirror so that the bottom surface is at 40" max. above the finished floor.	1	348	\$348

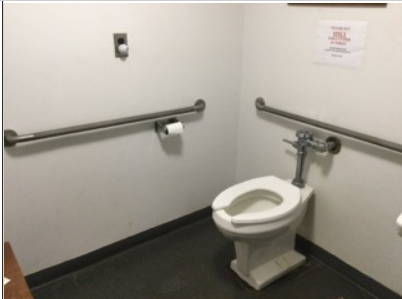
Flush control not on open side Centerline < or > 18" (MAAB) Toilet paper dispenser is not compliant	- 24.25" -	Relocate the flush control to the open side. Relocate toilet so that the centerline is 18" from the side wall. Relocate toilet paper so that it is 24" min. high, located under the grab bar, and between 7" and 9" from the front of the toilet.	1	3458	\$3458

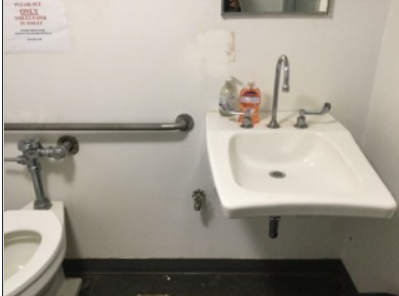
ID	Location	Floor	Room	Element	Type	Photo	Issues	Current Measure	Recommendations	Quantity	Price	Cost Estimation
34	Single-User Toilet Room	1		Single-User Toilet	N/A

Clearance at toilet < 60" clear width	-	Ensure there is 60" wide min. clear floor space the toilet and the lavatory.	1	-	\$0
35	Single-User Toilet Room	1		Single-User Toilet

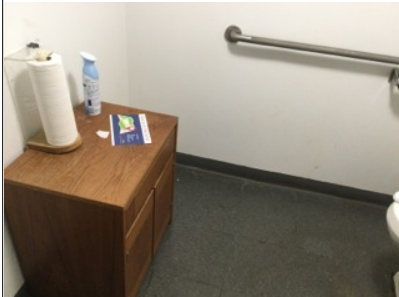
Distance between toilet and nearest fixture < 42"	-	Remove urinal to provide the required 42" min. distance between the toilet and the nearest fixture.	1	Labor	\$0
<b>Additional Access</b>												
<b>Drinking Fountains</b>												
36	Towards Town Clerk Office	2		Drinking Fountains	Low

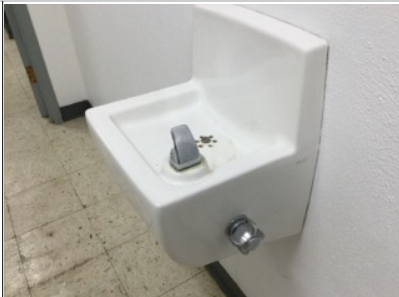
No drinking fountain provided for standing users Knee or toe clearance not provided	- -	Provide an additional drinking fountain for standing users or install a Hi-Lo drinking fountain. Provide knee and toe clearance, 27" min. high at drinking fountain for seated users.	1	4216	\$4216

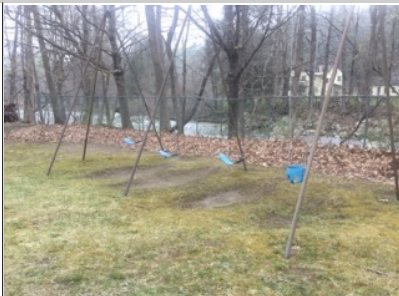
Accessible route not provided Accessible route not provided to play components Surface not stable, firm, and slip-resistant	- - -	Install an accessible route to and around the playground. Provide a compliant impact-attenuating surface to and around the play components and ensure that surface is firm, stable and slip-resistant (to areas around play components). (Cost for a new stone dust path to the swing set and impact-attenuating surface around the to the play components)	1	8310	\$8310
<b>Best Practice</b>

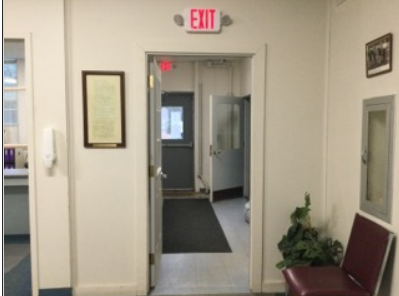
ID	Location	Floor	Room	Element	Type	Photo	Issues	Current Measure	Recommendations	Quantity	Price	Cost Estimation
1	Entrance	1			N/A

See Town Hall entrance for issues.	1	-	\$0
2		1		Doors, Doorways, & Gates	Other

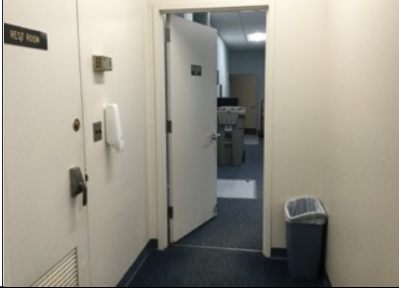
Door requires > 5 lbs. of force to open	8 lbs.	Adjust closers so doors do not require more than 5 pounds of force to open.	1	Labor	\$0
3	To Interrogation Room	1		Doors, Doorways, & Gates	Office

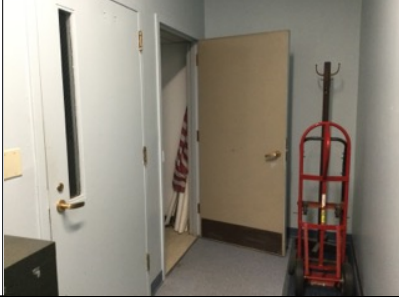
Maneuvering clearance(s) not provided	-	Remove storage to maintain the maneuvering clearance at the door.	1	Labor	\$0
4	To Interrogation Room	1		Signage	Designation

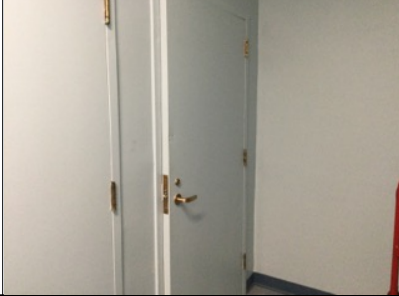
Signage is not provided	-	Locate compliant signage alongside the door on the latch side.	1	232	\$232
5	Chief's Office	1		Signage	Designation

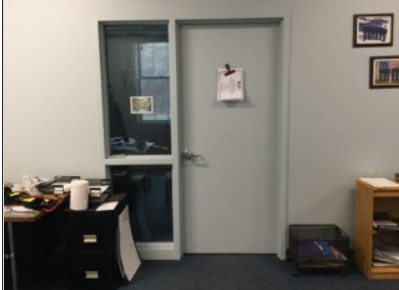
Signage is not provided	-	Locate compliant signage alongside the door on the latch side.	1	232	\$232

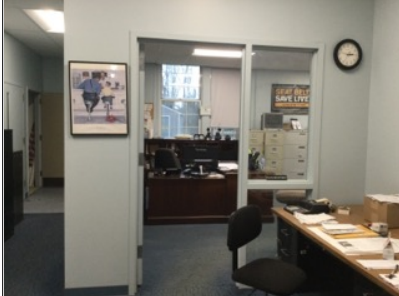
ID	Location	Floor	Room	Element	Type	Photo	Issues	Current Measure	Recommendations	Quantity	Price	Cost Estimation
6	Police Officers Work Area	1		Signage	Designation

Raised characters not provided on sign Raised characters < 48" or > 60" above ground	- -	Provide text with raised characters duplicated in braille on sign. Mount signs so that the baseline of the lowest tactile character is 48" min. above finished floor and the baseline of the highest tactile character is 60" max. above the finished floor.	1	232	\$232
7	Police Officers Work Area	1		Means of Egress	N/A

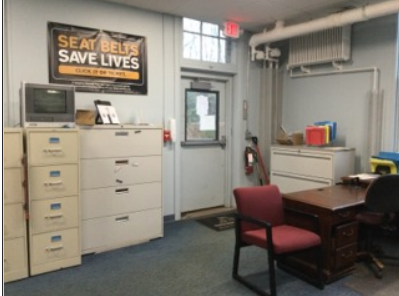
Tactile exit sign not provided Directional sign to accessible emergency exit not provided	- -	Ensure tactile exit signs with raised characters and braille are provided at exit doors. Mount signs between 48"- 60" above the finished floor located on the latch side of the door. Provide a directional sign indicating the location of the nearest accessible emergency exit.	1	464	\$464

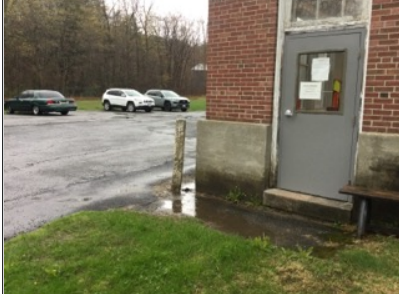
8	Employee Only Entrance	1		Entrance	Secondary Entrance

Not maintained in operable working condition		Ensure the employee entrance/exit is maintained in operable working condition.	1	-	\$0

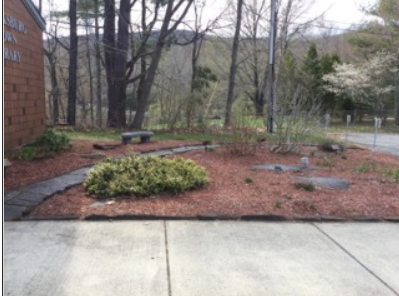
ID	Location	Floor	Room	Element	Type	Photo	Issues	Current Measure	Recommendations	Quantity	Price	Cost Estimation
<b>Approach and Entrance</b>												
<b>Exterior Access Route</b>												
1	Near Main Entrance -	Exterior		Exterior Access Route	Exterior

Exterior route < 36" wide	-	Ensure that a clear width of 36" min. is maintained at the accessible route.	1	384	\$384
2	Main Entrance	Exterior		Exterior Access Route	Exterior

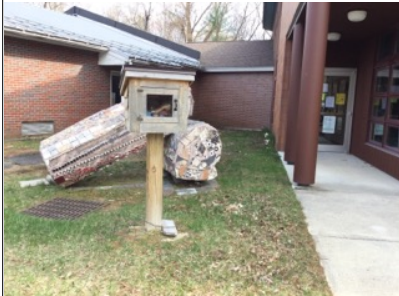
Accessible route not provided	-	Locate drop off box near the accessible route.	1	Labor	\$0
<b>Off-Street Parking Lot or Garage</b>												
3	Parking Lot	Exterior		Off-Street Parking Lot or Garage	Visitor

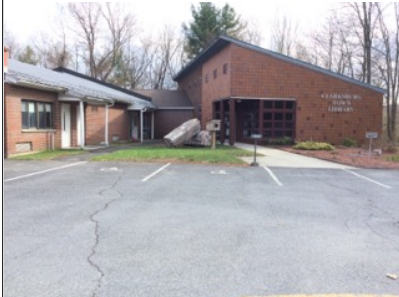
Access aisle not provided Sign not provided	- -	Provide a marked access aisle that is at least 96" wide. Provide a sign with the bottom of the sign 60" min. above the ground and the top 96" max. above the ground. Add the designation "Van Accessible" to the sign located at the van accessible space.	1	800	\$800

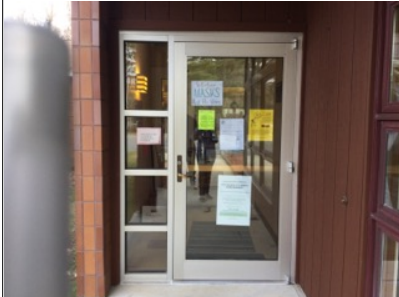
<b>Entrance</b>												
4	Main Entrance	Exterior		Entrance	Main Entrance

Door requires > 15 lbs. of force to open	18 lbs.	Adjust closers so door does not require more than 15 pounds of force.	1	Labor	\$0

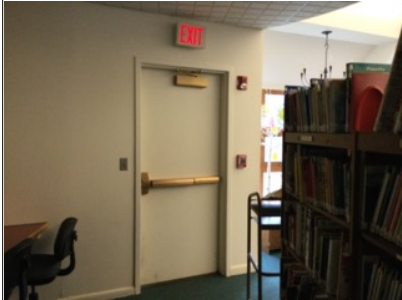
Tactile exit sign not provided Sign at area of refuge not provided	- -	Ensure a tactile exit sign with raised characters and braille is provided at exit door. Mount sign between 48"- 60" above the finished floor located on the latch side of the door. Provide a sign with the term "AREA OF REFUGE" and the International Symbol of Accessibility (ISA) at the door.	1	464	\$464
7	Main Entrance	1		Means of Egress	N/A

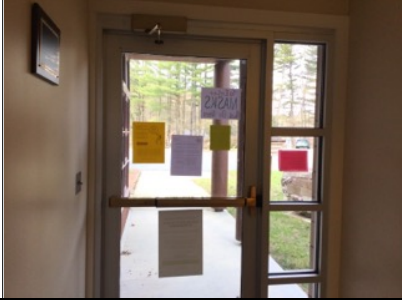
Tactile exit sign not provided Illuminated ISA symbol not provided (MAAB)	- -	Ensure a tactile exit sign with raised characters and braille is provided at exit door. Mount sign between 48"- 60" above the finished floor located on the latch side of the door. Provide an illuminated sign with the International Symbol of Accessibility.	1	464	\$464

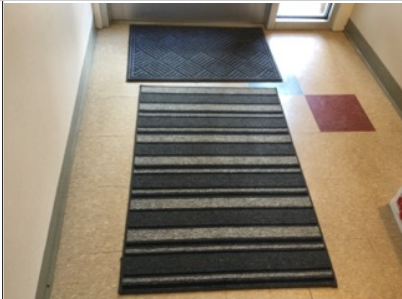
<b>Interior Access Route</b>												
8	Hallway	1		Interior Access Route	N/A

Surface not stable, firm, and slip-resistant	-	Ensure mat is securely attached to the floor.	1	Labor	\$0

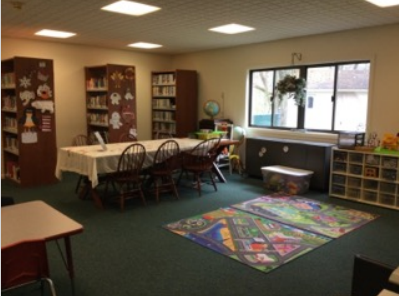
ID	Location	Floor	Room	Element	Type	Photo	Issues	Current Measure	Recommendations	Quantity	Price	Cost Estimation
9	Children Section	1		Interior Access Route	N/A

Surface not stable, firm, and slip-resistant	-	Ensure mat is securely attached to the floor.	1	Labor	\$0
10	Corridor	1		Interior Access Route	595	 	Surface not stable, firm, and slip-resistant	-	Ensure mat is securely attached to the floor.	1	Labor	\$0
<b>Doors, Doorways, &amp; Gates</b>												
11	Main Entrance/ Exit	1		Doors, Doorways, & Gates	Circulation

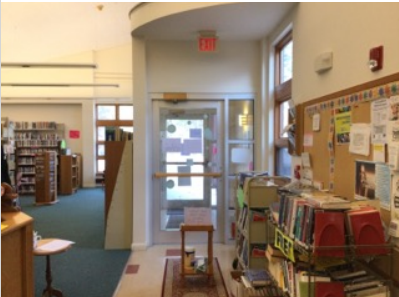
Maneuvering clearance(s) not provided	-	Relocate table to maintain the required maneuvering clearance at the door.	1	Labor	\$0
12	Hallway	1		Doors, Doorways, & Gates	Circulation

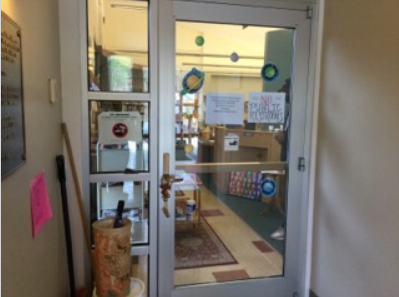
Maneuvering clearance(s) not provided Door requires > 5 lbs. of force to open	- 21 lbs.	Remove items to maintain the required maneuvering clearance at the door. Adjust closer so door does not require more than 5 pounds of force to open.	1	Labor	\$0

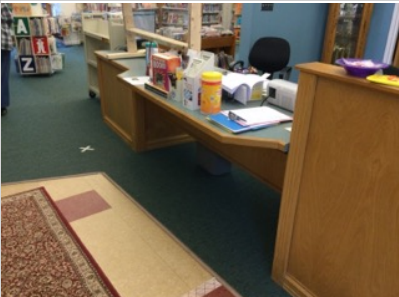
<b>Service Counter</b>												
13	Near Main Entrance	1		Service Counter	N/A

Counter not maintained in operable working condition	-	Remove objects to ensure the accessible portion of the counter is maintained in operable working condition.	1	Labor	\$0

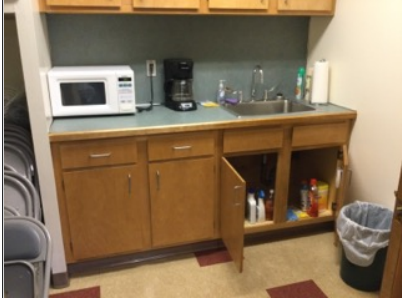
Knee/toe clearance not provided at sink	-	If the sink is used by members of the public, provide a sink with knee and toe clearance positioned for a forward approach.	1	-	\$0
<b>Toilet &amp; Bathing Rooms</b>												
<b>Lavatory</b>												
16	Single-User Toilet Room	1		Lavatory	N/A

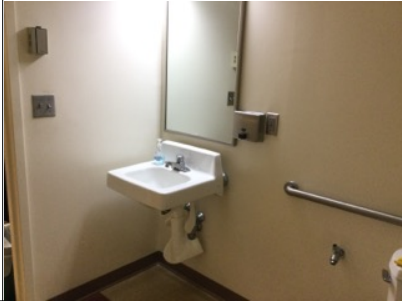
Toe or knee clearances not provided	25.5"	Provide a lavatory with knee and toe clearance positioned for a forward approach.	1	1686	\$1686

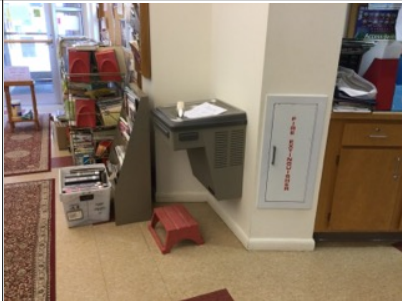
<b>Additional Access</b>												
<b>Drinking Fountains</b>												
17	Corridor	1		Drinking Fountains	Low

No drinking fountain provided for standing users	-	Provide an additional drinking fountain for standing users.	1	4028	\$4028
<b>Best Practice</b>

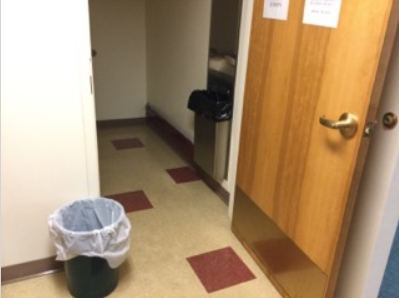
ID	Location	Floor	Room	Element	Type	Photo	Issues	Current Measure	Recommendations	Quantity	Price	Cost Estimation
<b>Signage</b>												
18	Single-User Toilet Room	1		Signage	N/A

Recommend providing a sign with raised characters and braille mounted on the latch side of the door at the single-user toilet room.	1	-	\$0

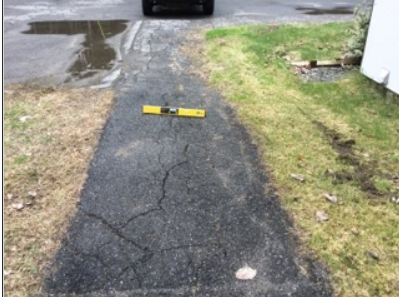
ID	Location	Floor	Room	Element	Type	Photo	Issues	Current Measure	Recommendations	Quantity	Price	Cost Estimation
<b>Approach and Entrance</b>												
<b>Exterior Access Route</b>												
1	Path to Parking From Exit Near Kitchen	Exterior		Exterior Access Route	Walkway

Cross slope > 1:50 (2.00%)	12%	Reduce cross slope to be no steeper than 1:50 (2.00%).	1	-	\$0
2	To Main Entrance/ Exit	Exterior		Exterior Access Route	Exterior

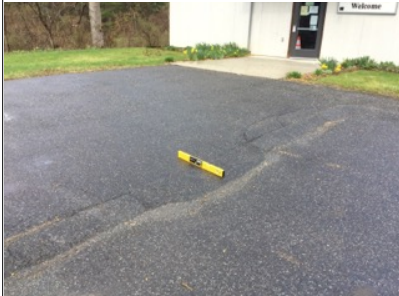
Running slope > 1:20 (5%)	16.3%	Reduce running slope to be no steeper than 1:20 (5%).	1	-	\$0
3	To Main Entrance/ Exit	Ext.		Exterior Access Route	Exterior

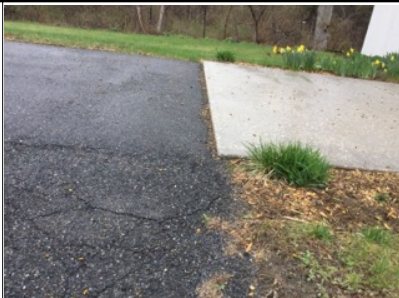
Level changes > 1/4"	1"	Alter change in level to be 1/4" high max.	1	256	\$256
4	Exit Near Kitchen	Exterior		Exterior Access Route	Exterior

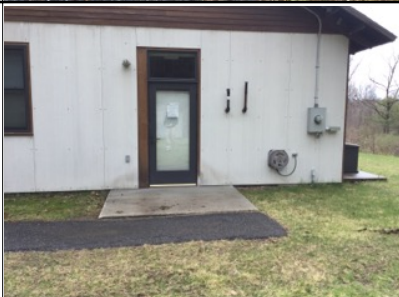
Level changes > 1/4"	1"	Alter change in level to be 1/4" high max.	1	256	\$256
<b>Off-Street Parking Lot or Garage</b>												
5	Accessible Parking Sign Near Main Entrance/ Exit	Ext.		Off-Street Parking Lot or Garage	Visitor

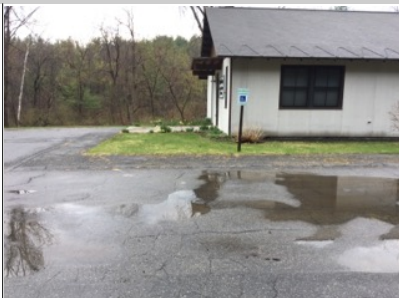
Total # of designated van accessible spaces	-	Provide a van accessible spaces with a marked access aisle that is at least 96" wide and add the designation "Van Accessible" to the sign. Ensure sign is mounted between 60" -96" above the ground.  Note: Provide one van accessible space for every six accessible parking spaces.	1	1850	\$1850

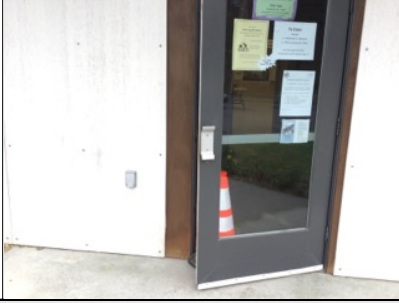
Door requires > 15 lbs. of force to open	26 lbs.	Adjust closers so doors do not require more than 15 pounds of force.	1	Labor	\$0
<b>Access to Goods and Services</b>												
<b>Means of Egress</b>												
9	Main Entrance/Exit	1		Means of Egress	N/A

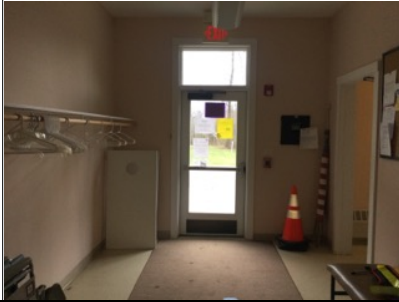
Tactile exit sign not provided Illuminated ISA symbol not provided (MAAB)	- -	Ensure a tactile exit sign with raised characters and braille is provided at exit door. Mount sign between 48"- 60" above the finished floor located on the latch side of the door. Provide an illuminated sign with the International Symbol of Accessibility.	1	464	\$464

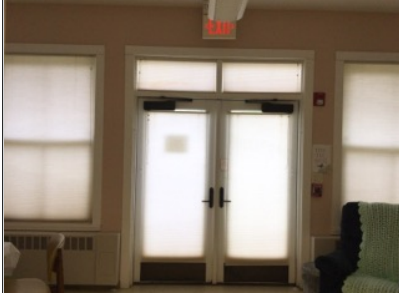
10	Exit - Side Lounge	1		Means of Egress

Tactile exit sign not provided Illuminated ISA symbol not provided (MAAB)	- -	Ensure a tactile exit sign with raised characters and braille is provided at exit door. Mount sign between 48"- 60" above the finished floor located on the latch side of the door. Provide an illuminated sign with the International Symbol of Accessibility.	1	464	\$464

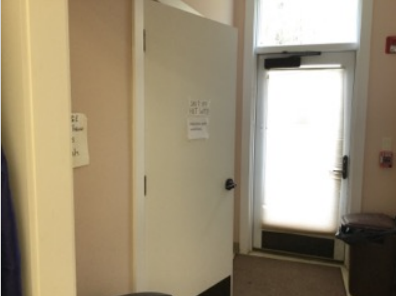
ID	Location	Floor	Room	Element	Type	Photo	Issues	Current Measure	Recommendations	Quantity	Price	Cost Estimation
11	Exit Near Kitchen	1		Means of Egress	N/A

Tactile exit sign not provided Illuminated ISA symbol not provided (MAAB)	-	Ensure a tactile exit sign with raised characters and braille is provided at exit door. Mount sign between 48"- 60" above the finished floor located on the latch side of the door. Provide an illuminated sign with the International Symbol of Accessibility.	1	464	\$464
12	Exit Near Kitchen	1		Means of Egress	N/A

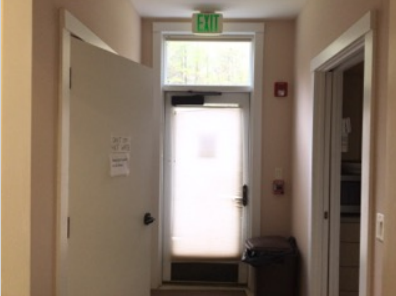
Tactile exit sign not provided Illuminated ISA symbol not provided (MAAB)	- -	Ensure tactile exit signs with raised characters and braille are provided at exit doors. Mount signs between 48"- 60" above the finished floor located on the latch side of the door. Provide an illuminated sign with the International Symbol of Accessibility.	1	464	\$464
<b>Doors, Doorways, &amp; Gates</b>

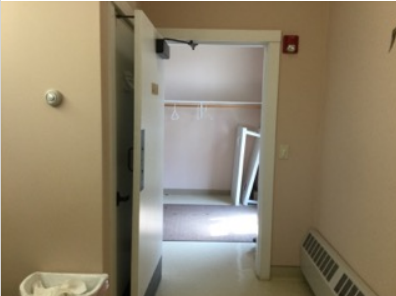
13	Men's Toilet Room	1		Doors, Doorways, & Gates	Toilet Room

Maneuvering clearance(s) not provided	13.75"	Provide an automatic door opener.	1	3060	\$3060
14	To Main Entrance/ Exit From Hall	1		Doors, Doorways, & Gates	Circulation

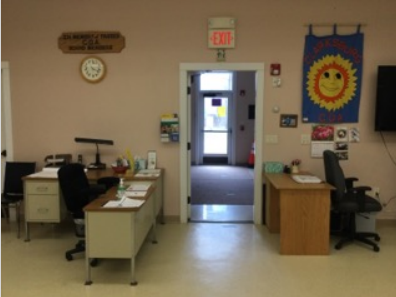
Maneuvering clearance(s) not provided	-	Relocate desk to maintain the maneuvering clearance at the door.	1	Labor	\$0
15	Main Hall	1		Doors, Doorways, & Gates	Office

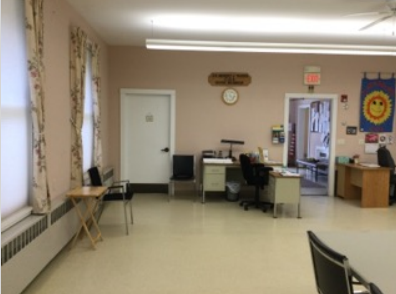
Maneuvering clearance(s) not provided	-	Relocate chair to maintain the maneuvering clearance at the door.	1	Labor	\$0

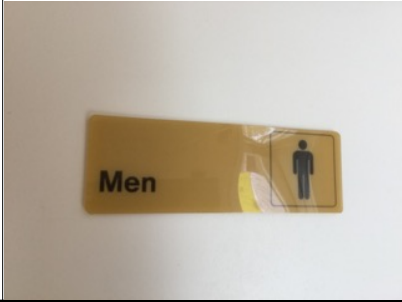
Raised characters not provided on sign Braille not provided on sign Sign not located on the latch side of the door	- - -	Provide text with raised characters duplicated in braille on sign. Mount sign so that the baseline of the lowest tactile character is 48" min. above finished floor and the baseline of the highest tactile character is 60" max. above the finished floor. Locate sign at permanent rooms alongside the door on the latch side.	1	232	\$232
18	Women's Toilet Room	1		Signage	Designation

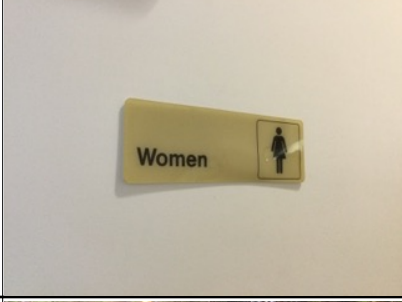
Raised characters not provided on sign Braille not provided on sign Sign not located on the latch side of the door	- - -	Provide text with raised characters duplicated in braille on sign. Mount sign so that the baseline of the lowest tactile character is 48" min. above finished floor and the baseline of the highest tactile character is 60" max. above the finished floor. Locate sign at permanent rooms alongside the door on the latch side.	1	232	\$232

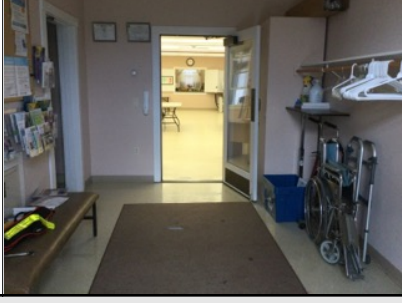
Reach < 15" or > 48"(forward/side approach)	61.5"	Relocate clothes rod 48" max. above the finished floor.	1	256	\$256
<b>Toilet &amp; Bathing Rooms</b>

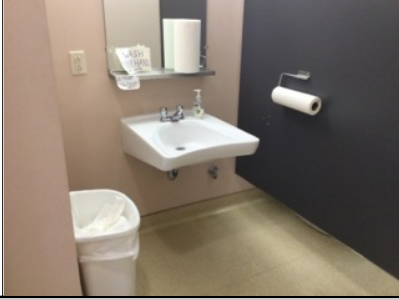
Toe or knee clearances not provided Plumbing underneath is exposed Mirror above lavatory w/reflective surface > 40"	25.25" - 42.25"	Provide a lavatory with knee and toe clearance positioned for a forward approach. Insulate or otherwise configure pipes to prevent contact for at lavatory. Lower mirror so that the bottom surface is at 40" max. above the finished floor.	1	1942	\$1942

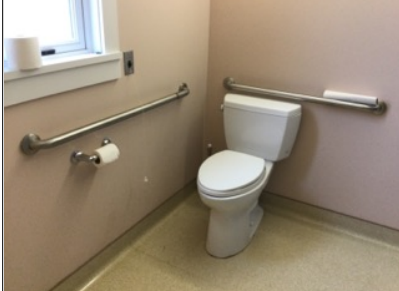
Rear grab bar < 42" long (MAAB) Flush control not on open side	36" -	Provide a rear wall grab bar that is 42" long min. and extends from the toilet 12" min. on one side and 24" min. on the other side (open side). Provide the flush control on the open side of the toilet (transfer side).	1	1272	\$1272

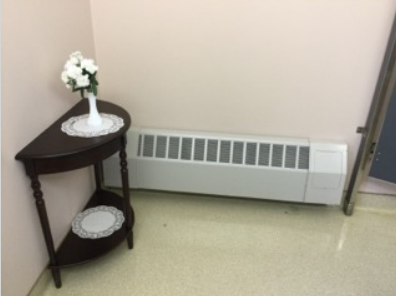
Clearance at toilet < 72" clear depth (MAAB)	-	Remove table to maintain the maintain the required maneuvering clearance at the toilet.	1	Labor	\$0
27	Women's Toilet Room	1		Toilet Compartment	Accessible Compartment

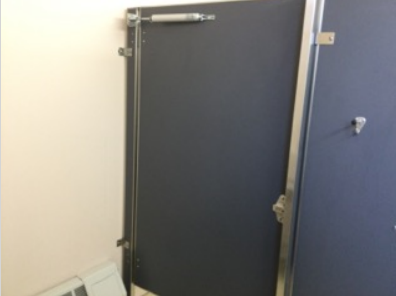
Door pull not provided	-	Provide a door pull on both sides of the door near the latch.	1	70	\$70
<b>Best Practice</b>												
<b>Bulletin Board</b>												
28	Near Toilet Rooms	1		Bulletin Board	N/A

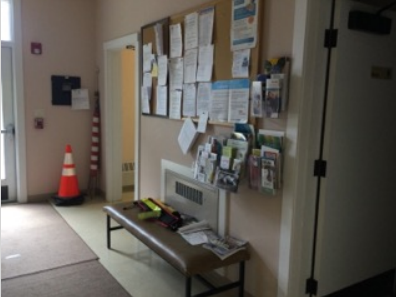
Recommend relocating the bench and lower the bulletin board so information is mounted within reach range.	1	-	\$0
<b>Parking</b>												
29	Exit Near Kitchen	1		Parking	N/A

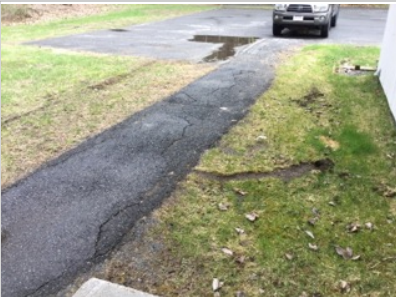
Recommend providing a marking so parked cars do not block the accessible route.	1	-	\$0
30	Path Along Parking	1		Parking	N/A

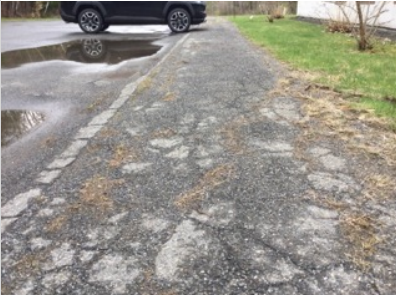
Recommend providing wheel stops to keep vehicles from reducing the clear width of the accessible route.	1	-	\$0

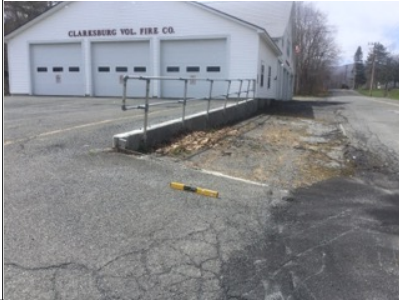
Cross slope > 1:50 (2.00%) Running slope > 1:20 (5%)	4.8% 132%	Reduce cross slope to be no steeper than 1:50 (2.00%). Reduce running slope to be no steeper than 1:20 (5%).	1	-	\$0
3	Route From Side Garage to Middle Garage	1		Exterior Access Route	182

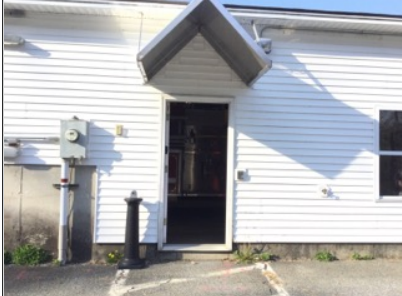
Entrance not on an accessible route	-	Consider providing a temporary ramp as needed.	1	500	\$500
6	Back Entrance/ Exit	1		Entrance	Main Entrance

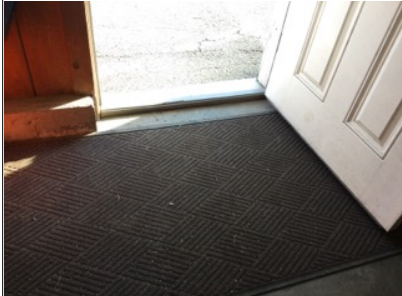
Threshold not beveled Threshold > 1/2" high	- 1.5"	Bevel the threshold. Alter threshold to be 1/2" high max.	1	300	\$300
7	Back Entrance/ Exit	1		Entrance	Main Entrance

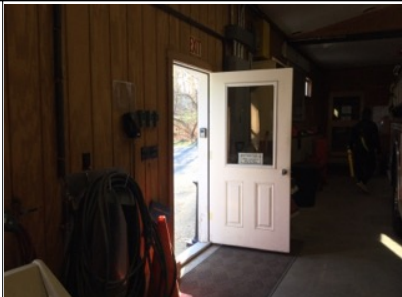
Hardware not operable with a closed fist	-	Provide hardware that can be operable with one hand and not require tight grasping, pinching, or twisting of the wrist.	1	484	\$484
<b>Access to Goods and Services</b>												
<b>Interior Access Route</b>												
8	Side Garage Roadside Garage Doors	1		Interior Access Route	N/A

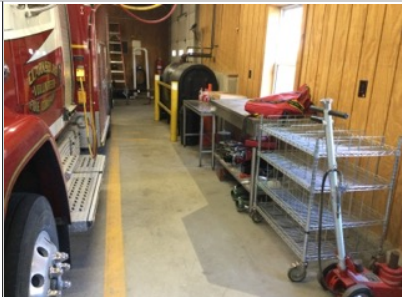
Ensure there is a 36" clear width when members of the public are allowed to visit the station.	1	-	\$0

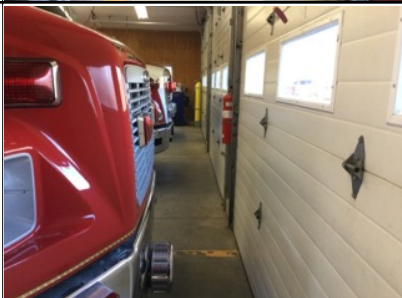
9	Side Garage Door, Cross Road - Northeast Side	1		Interior Access Route	N/A

Obstructed by protruding objects	7"	Relocate fire extinguisher so it does not protrude into the circulation path.	1	Labor	\$0

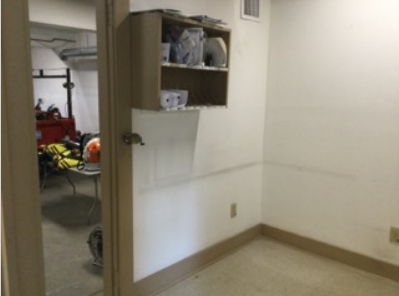
Obstructed by protruding objects	-	Relocate shelving so it does not protrude into the circulation path.	1	256	\$256
11	Towards Single-User Toilet Room	1		Interior Access Route	N/A

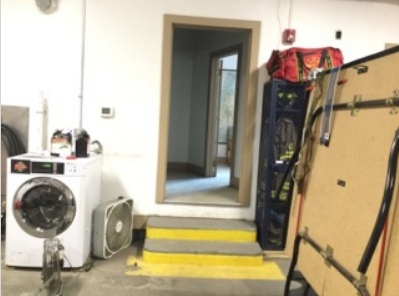
Accessible route not provided	-	See ID #12.	1	-	\$0
12	Towards Single-User Toilet Room	1		Interior Access Route	N/A

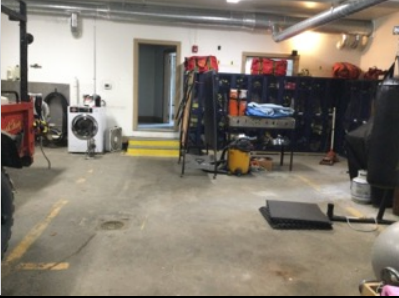
Accessible route not provided	-	Provide an accessible route. Consider providing a wooden ramp along the wall to the right of the entrance. Ensure the ramp is at least 20 ft. long with a landing that is at least 5 ft. and a slope no steeper than 1:12 (8.33%).	1	10000	\$10000
<b>Signage</b>												
13	Single-User Toilet Room	1		Signage	Designation

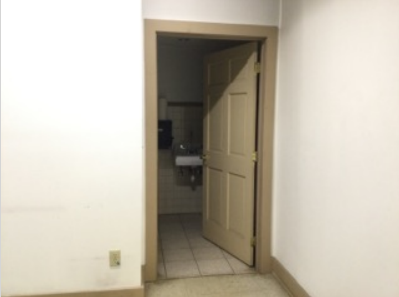
Signage is not provided	-	Locate compliant signage alongside the door on the latch side.	1	232	\$232

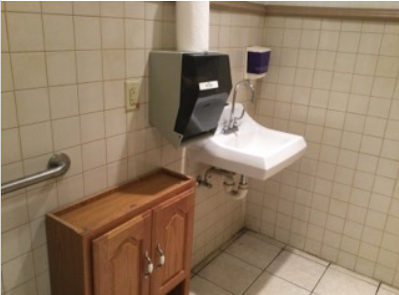
<b>Toilet &amp; Bathing Rooms</b>												
<b>Overall Access</b>												
14	Single-User Toilet Room	1		Overall Access	Toilet Room

Audible and visible alarms not provided	-	When fire system is updated, ensure that a visible and audible fire alarm is installed.	1	-	\$0

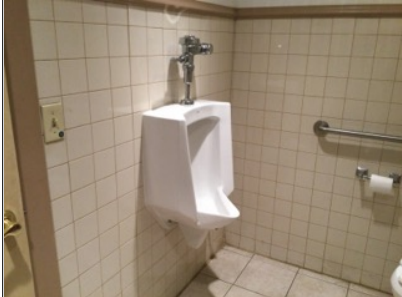
Rim > 17" high	24"	See ID #15.	1	-	\$0

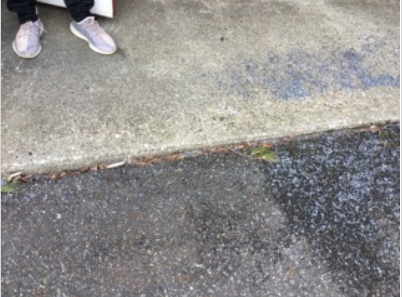
Level changes > 1/4"	2.5"	Alter change in level to be 1/4" high max.	1	256	\$256
2	Exit - Special Ed	Exterior	5	Exterior Access Route	Exterior

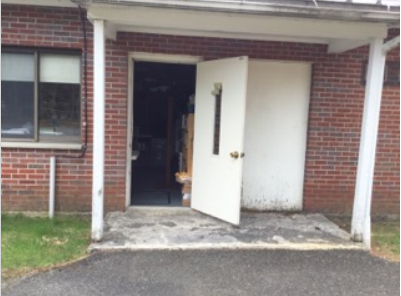
Level changes > 1/4"	1.5"	Alter change in level to be 1/4" high max.	1	256	\$256
3	Exit Path Between Library and School Primary Wing	Exterior	5	Exterior Access Route	Walkway

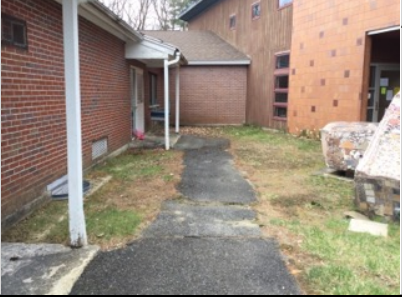
Route not maintained in operable working condition	-	Ensure the accessible route is maintained in operable working condition.  (Cost for a 120 ft. by 4 ft. wide concrete walkway.)	1	7680	\$7680
4	Exit Path Between Library and School Primary Wing	Exterior	5	Exterior Access Route	Walkway

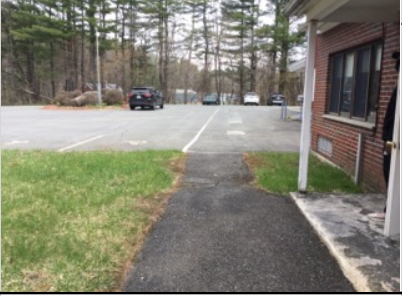
Route not maintained in operable working condition	-	Ensure the accessible route is maintained in operable working condition.  (See ID #3 for cost.)	1	-	\$0

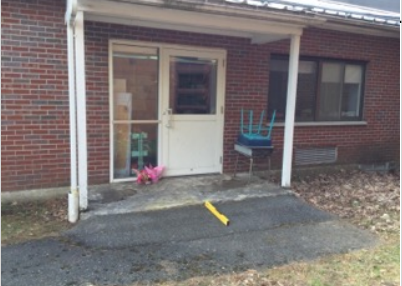
5	Exit #3	1		Exterior Access Route	Exterior

Running slope > 1:20 (5%)	11%	Reduce running slope to be no steeper than 1:20 (5%).	1	1200	\$1200

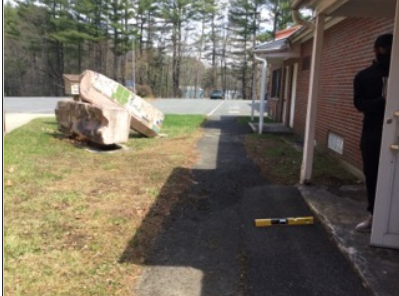
Level changes > 1/4"	1"	Alter change in level to be 1/4" high max.	1	256	\$256
7	Gym Entrance/ Exit Near Playground	B		Exterior Access Route	Sidewalk

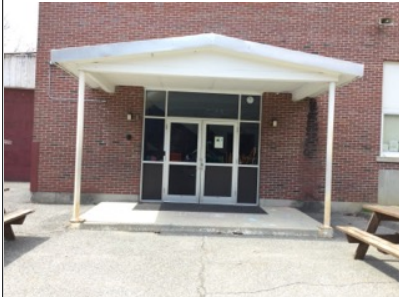
Level changes > 1/4"	5.5"	Alter change in level to be 1/4" high max.	1	256	\$256
8	Towards Gym Entrance	Ext.		Exterior Access Route	Exterior

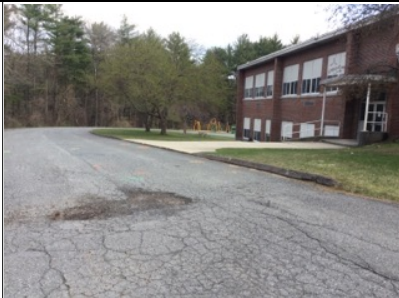
Route not maintained in operable working condition	-	Ensure the accessible route is maintained in operable working condition.	1	-	\$0
<b>Off-Street Parking Lot or Garage</b>												
9	Parking Lot	Ext.		Off-Street Parking Lot or Garage	Visitor

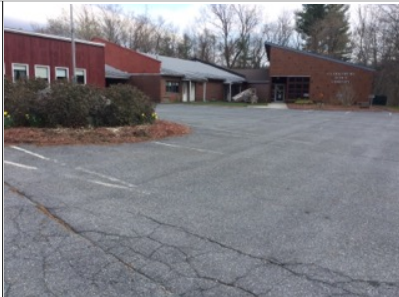
Parking not maintained in operable working condition	-	Ensure parking is maintained in operable working condition.  Note: See the catalog for the Library for accessibility issues.	1	-	\$0
<b>Emergency Exit</b>

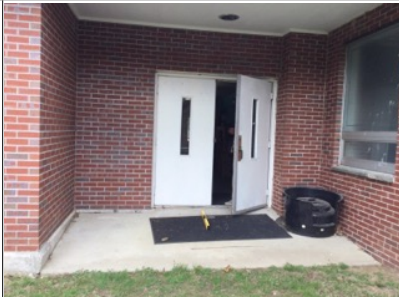
10	Exit Near Storage by Grade 2	Exterior		Emergency Exit	N/A

Maneuvering clearance(s) not provided	11.7%	Ensure running slope is no more than 1:50 (2.00%) in all directions.  Cost for adding concrete to correct running slope.	1	1200	\$1200

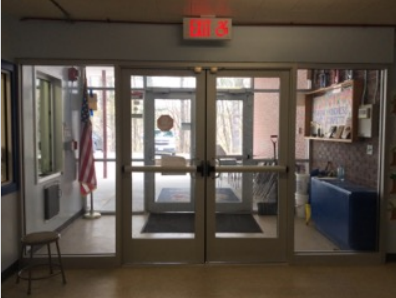
Tactile exit sign not provided	-	Ensure a tactile exit sign with raised characters and braille is provided at exit door. Mount sign between 48"- 60" above the finished floor located on the latch side of the door.	1	232	\$232
17	Exit - OT/ PT/Special Ed	1		Means of Egress

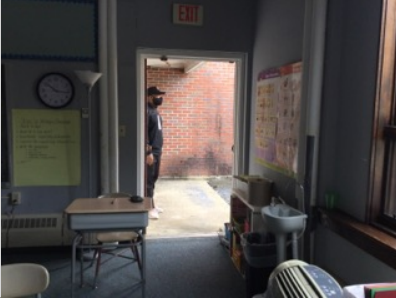
Tactile exit sign not provided	-	Ensure a tactile exit sign with raised characters and braille is provided at exit door. Mount sign between 48"- 60" above the finished floor located on the latch side of the door.  After the change in level is fixed, provide an illuminated sign with the International Symbol of Accessibility (ISA). (See ID # 1.)	1	232	\$232
18	Exit Near Storage by Grade 2	1		Means of Egress	N/A

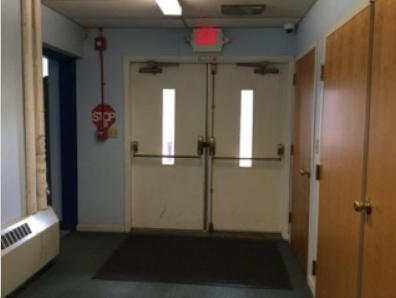
Tactile exit sign not provided	- -	Ensure a tactile exit sign with raised characters and braille is provided at exit door. Mount sign between 48"- 60" above the finished floor located on the latch side of the door.	1	232	\$232

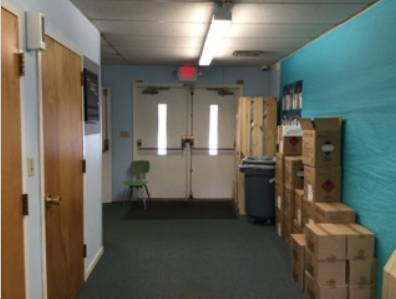
19	Opposite Exit Near Grade 2	1		Means of Egress	N/A

Tactile exit sign not provided	-	Ensure a tactile exit sign with raised characters and braille is provided at exit door. Mount sign between 48"- 60" above the finished floor located on the latch side of the door.  After the change in level is fixed, provide an illuminated sign with the International Symbol of Accessibility (ISA). (See ID # 1.)	1	232	\$232
20	Special Ed	1	5	Means of Egress

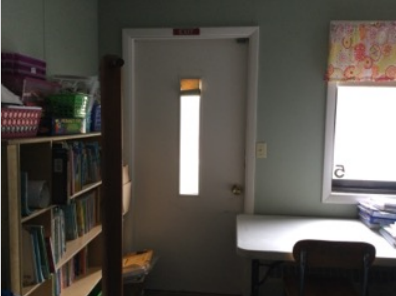
Tactile exit sign not provided		Ensure a tactile exit sign with raised characters and braille is provided at exit door. Mount sign between 48"- 60" above the finished floor located on the latch side of the door.  After the change in level is fixed, provide an illuminated sign with the International Symbol of Accessibility (ISA). (See ID #2.)	1	232	\$232

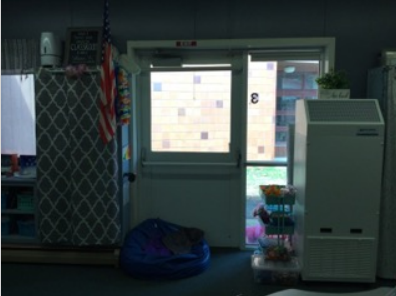
Tactile exit sign not provided	-	Ensure a tactile exit sign with raised characters and braille is provided at exit door. Mount sign between 48"- 60" above the finished floor located on the latch side of the door.  After the running slope is fixed, provide an illuminated sign with the International Symbol of Accessibility (ISA). (See ID #5.)	1	232	\$232
22	Exit at Rear End of Primary Wing - Near Library Entrance	1		Means of Egress	N/A

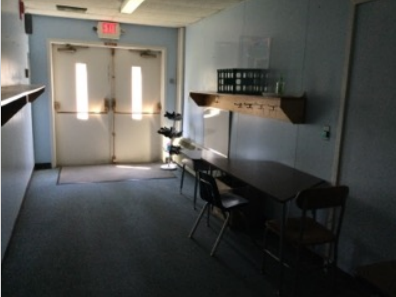
Tactile exit sign not provided	- -	Ensure a tactile exit sign with raised characters and braille is provided at exit door. Mount sign between 48"- 60" above the finished floor located on the latch side of the door. Provide a directional sign to the nearest accessible exit.	1	232	\$232
23	Grade 1	1	2	Means of Egress	N/A

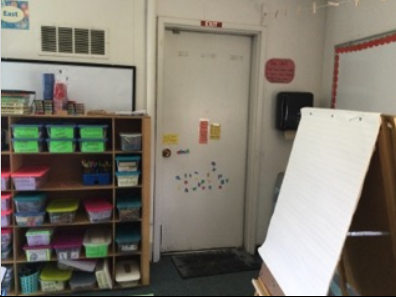
Tactile exit sign not provided		Ensure a tactile exit sign with raised characters and braille is provided at exit door. Mount sign between 48"- 60" above the finished floor located on the latch side of the door. Provide a directional sign to the nearest accessible exit.	1	232	\$232

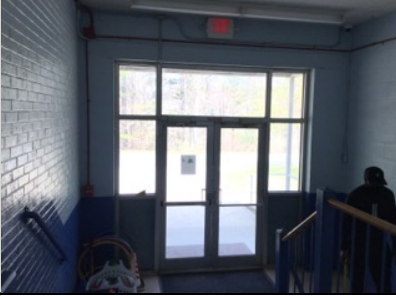
24	Exit Near Lift Between Middle Wing and Junior High Wing	.5		Means of Egress	N/A

Tactile exit sign not provided	-	Ensure a tactile exit sign with raised characters and braille is provided at exit door. Mount sign between 48"- 60" above the finished floor located on the latch side of the door. Provide a directional sign to the nearest accessible exit.	1	232	\$232
25	Gym Entrance/ Exit Near Playground	B		Means of Egress	N/A

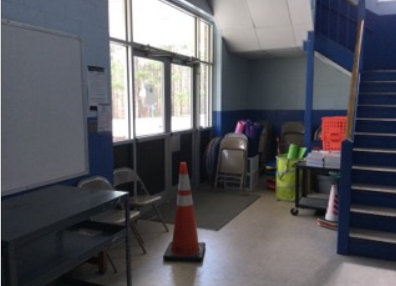
Tactile exit sign not provided Door requires > 15 lbs. of force to open	- -	Ensure a tactile exit sign with raised characters and braille is provided at exit door. Mount sign between 48"- 60" above the finished floor. Adjust closers of exterior door so door does not require more than 15 pounds of force.  After the change in level is fixed, provide an illuminated sign with the International Symbol of Accessibility (ISA). (See ID #7.)	1	232	\$232

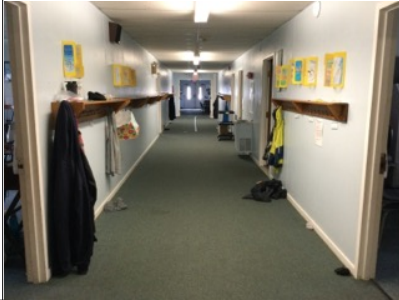
Obstructed by protruding objects	5.5	Relocate coat hooks so they do not protrude into the circulation path.	2	256	\$512
28	Students Accessible Toilet Room	1		Interior Access Route	N/A

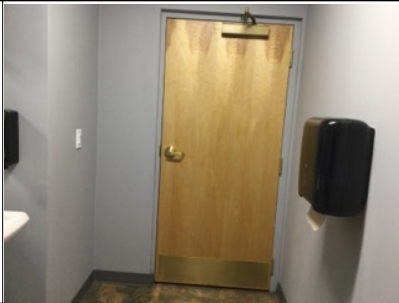
Obstructed by protruding objects	7.5"	Relocate paper towel dispenser so it does not protrude into the circulation path. Adjust closer so door does not require more than 5 pounds of force to open.	1	256	\$256
29		B		Interior Access Route	N/A

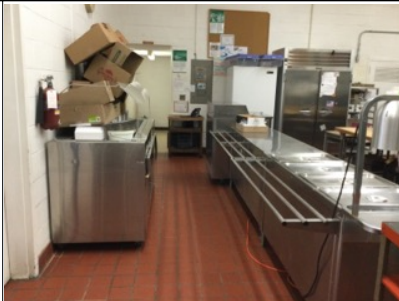
Route < 36" wide Obstructed by protruding objects	28" -	Ensure that a clear width of 36" min. is maintained at the accessible route. Provide a cane-detectable barrier under the tray slide.	1	239	\$239
