## Town of Clarksburg, Massachusetts

## Municipal Buildings

# Town Hall

## Town of Clarksburg ADA Transition Plan

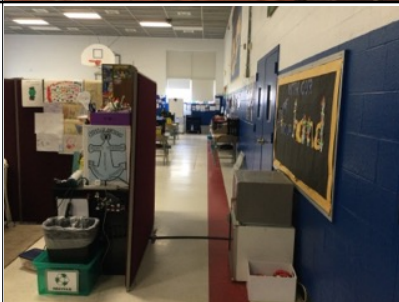
30	Gym	B		Interior Access Route	N/A

Route < 36" wide	-	Ensure that a clear width of 36" min. is maintained at the accessible route.	1	Labor	\$0

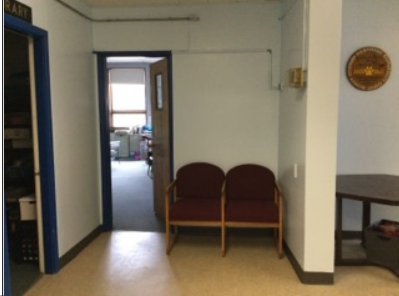
Clear width at door < 32" Hardware not operable with a closed fist	28" -	Widen the door so that there is 32" min. clear width. Provide hardware that can be operable with one hand and not require tight grasping, pinching, or twisting of the wrist.	1	3850	\$3850
33	OT/PT/ Special Ed	1		Doors, Doorways, & Gates	Office

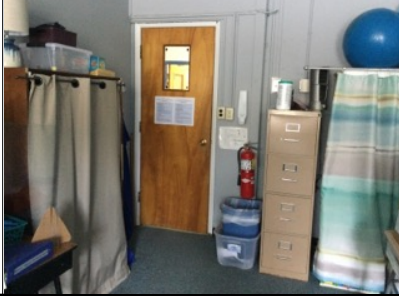
Maneuvering clearance(s) not provided	11"	Remove storage to maintain the maneuvering clearance at the door.	1	Labor	\$0

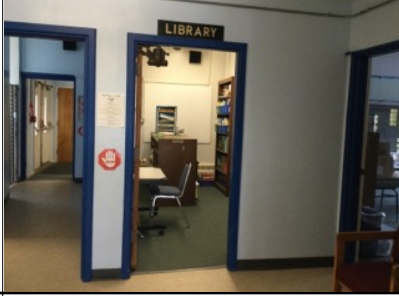
34	Staff Room	1		Doors, Doorways, & Gates	N/A

Hardware not operable with a closed fist	-	Provide hardware that can be operable with one hand and not require tight grasping, pinching, or twisting of the wrist. Remove sign to reflect the actual use of the room.	1	484	\$484
35	Student Support Center	1		Doors, Doorways, & Gates	Meeting Room

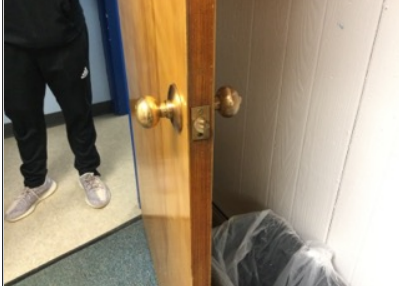
Hardware not operable with a closed fist	-	Provide hardware that can be operable with one hand and not require tight grasping, pinching, or twisting of the wrist.	1	484	\$484

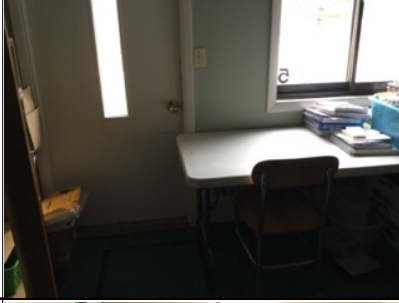
Maneuvering clearance(s) not provided Hardware not operable with a closed fist	- -	Relocate table to maintain the maneuvering clearance at the door. Provide hardware that can be operable with one hand and not require tight grasping, pinching, or twisting of the wrist.	1	484	\$484
38	Boys' Toilet Room	1		Doors, Doorways, & Gates	Toilet Room

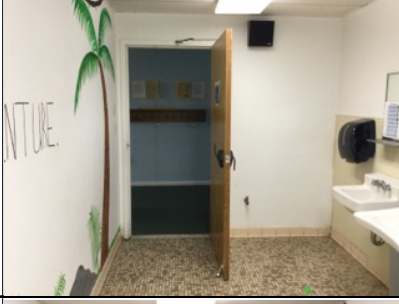
Maneuvering clearance(s) not provided	-	Reverse the swing of the door to provide maneuvering clearance.	1	1884	\$1884

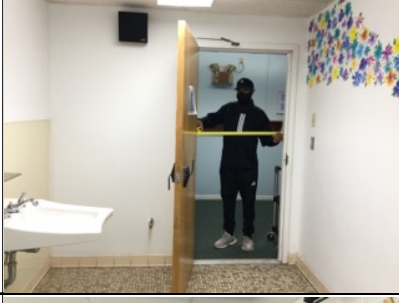
39	Girls' Toilet Room	1		Doors, Doorways, & Gates	Toilet Room

Maneuvering clearance(s) not provided	-	Reverse the swing of the door to provide maneuvering clearance.	1	1884	\$1884
40	Grade 1	1	2	Doors, Doorways, & Gates	Classroom

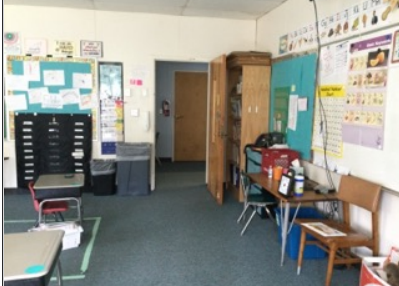
Maneuvering clearance(s) not provided	-	Relocate trash can to maintain the maneuvering clearance at the door.	1	Labor	\$0

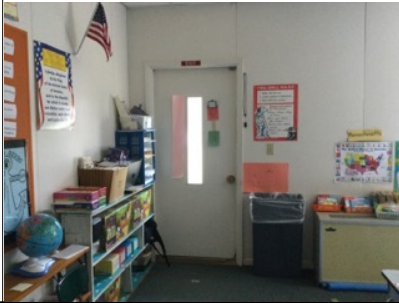
Maneuvering clearance(s) not provided Hardware not operable with a closed fist	- -	Relocate trash can to main the maneuvering clearance at the door. Provide hardware that can be operable with one hand and not require tight grasping, pinching, or twisting of the wrist.	1	484	\$484
43	Grade 2	1	6	Doors, Doorways, & Gates	Classroom

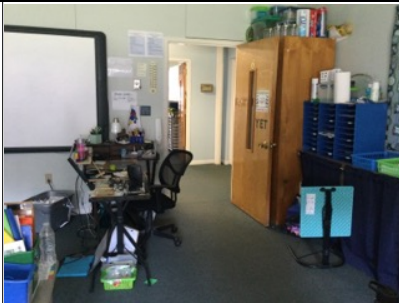
Maneuvering clearance(s) not provided Hardware not operable with a closed fist	- -	Relocate storage to main the maneuvering clearance at the door. Provide hardware that can be operable with one hand and not require tight grasping, pinching, or twisting of the wrist.	1	484	\$484

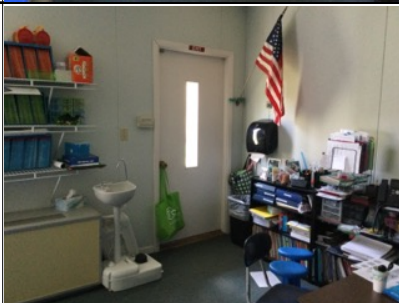
44	Grade 2	1	6	Doors, Doorways, & Gates	Emergency Egress

Maneuvering clearance(s) not provided Hardware not operable with a closed fist	- -	Relocate storage to main the maneuvering clearance at the door. Provide hardware that can be operable with one hand and not require tight grasping, pinching, or twisting of the wrist.	1	484	\$484
45	OT/PT/ Special Ed	1	9	Doors, Doorways, & Gates	Classroom

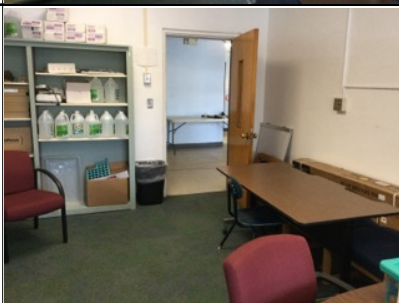
Maneuvering clearance(s) not provided Hardware not operable with a closed fist	- -	Relocate table and trash can to maintain the maneuvering clearance at the door. Provide hardware that can be operable with one hand and not require tight grasping, pinching, or twisting of the wrist.	1	484	\$484

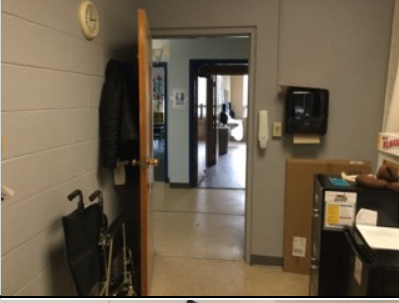
Hardware not operable with a closed fist	-	Provide hardware that can be operable with one hand and not require tight grasping, pinching, or twisting of the wrist.	1	484	\$484
48	Grade 3	1	12	Doors, Doorways, & Gates	Classroom

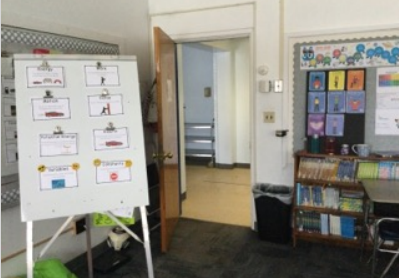
Maneuvering clearance(s) not provided Hardware not operable with a closed fist	- -	Relocate trash can to maintain the required maneuvering clearance at the door.	1	Labor	\$0

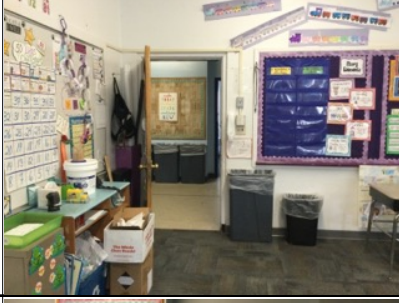
Maneuvering clearance(s) not provided Hardware not operable with a closed fist	- -	Relocate trash can to maintain the required maneuvering clearance at the door. Provide hardware that can be operable with one hand and not require tight grasping, pinching, or twisting of the wrist.	1	484	\$484
53	Grade 5	1	13	Doors, Doorways, & Gates	Classroom

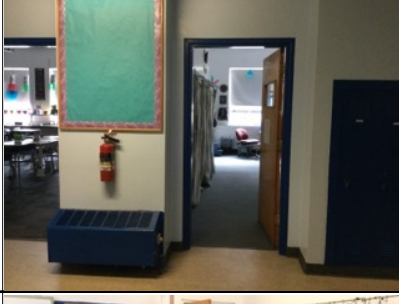
Hardware not operable with a closed fist	-	Provide hardware that can be operable with one hand and not require tight grasping, pinching, or twisting of the wrist.  (See ID #54 for cost.)	1	-	\$0

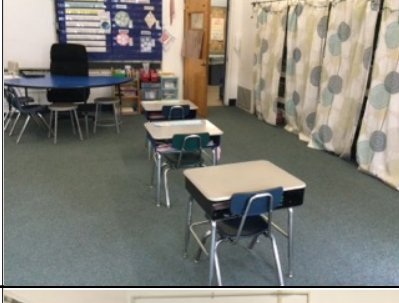
54	Grade 5	1	13	Doors, Doorways, & Gates	Classroom

Maneuvering clearance(s) not provided	6"	Reverse the swing of the door to provide the required 18" maneuvering clearance.	1	1884	\$1884
55	Grade 5	1	13	Doors, Doorways, & Gates	Classroom

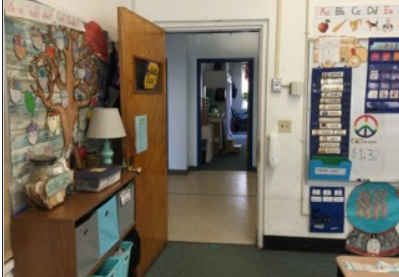
Hardware not operable with a closed fist	-	Provide hardware that can be operable with one hand and not require tight grasping, pinching, or twisting of the wrist.	1	484	\$484

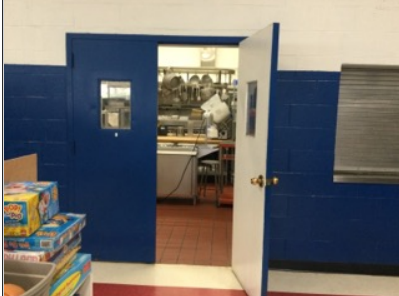
Clear width at door < 32" Hardware not operable with a closed fist	28" -	Keep both doors open to maintain a 32" min. width at the door. Provide hardware that can be operable with one hand and not require tight grasping, pinching, or twisting of the wrist.	1	484	\$484
57	Exit From Kitchen to Gym	B		Doors, Doorways, & Gates	Other

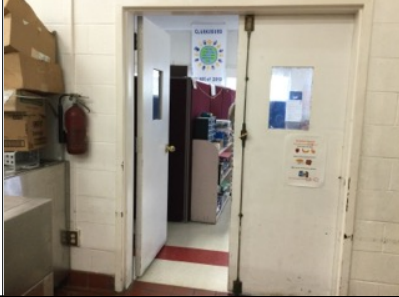
Clear width at door < 32" Hardware not operable with a closed fist	28" -	Keep both doors open to maintain a 32" min. width at the door. Provide hardware that can be operable with one hand and not require tight grasping, pinching, or twisting of the wrist.	1	484	\$484
58	To Toilet Rooms Near Gym Opposite Gym Entrance/ Exit	B		Doors, Doorways, & Gates	Circulation

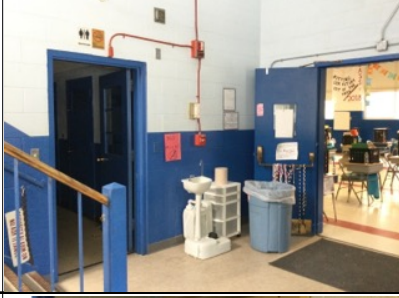
Hardware not operable with a closed fist	-	Provide hardware that can be operable with one hand and not require tight grasping, pinching, or twisting of the wrist.	1	484	\$484

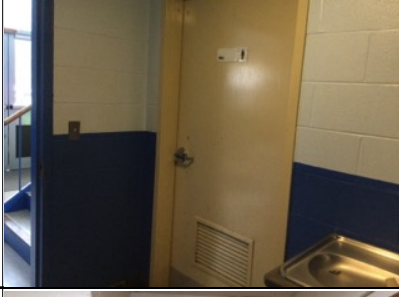
59	Men's Toilet Room	B		Doors, Doorways, & Gates	Toilet Room

Maneuvering clearance(s) not provided	8"	Provide an automatic door opener.  (See ID #60 for cost.)	1	-	\$0
60	Men's Toilet Room	B		Doors, Doorways, & Gates	Toilet Room

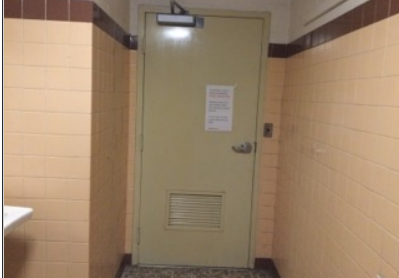
Maneuvering clearance(s) not provided	7.5"	Provide an automatic door opener.	1	3060	\$3060

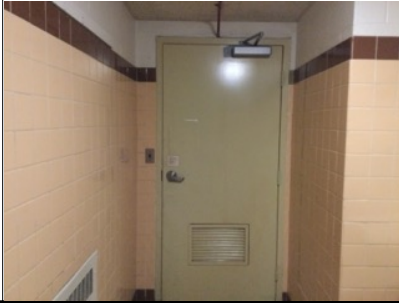
Maneuvering clearance(s) not provided	8"	Provide an automatic door opener.	1	3060	\$3060
63	Grade 6/ Science	1.5	18	Doors, Doorways, & Gates	Classroom

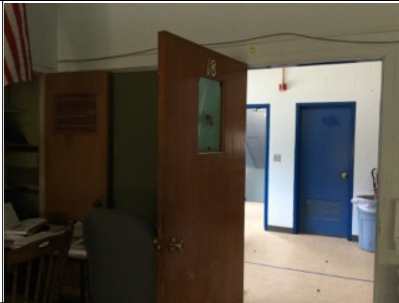
Hardware not operable with a closed fist	-	Provide hardware that can be operable with one hand and not require tight grasping, pinching, or twisting of the wrist.	1	484	\$484
64	Grade 6/ Science	1.5	18	Doors, Doorways, & Gates	Classroom

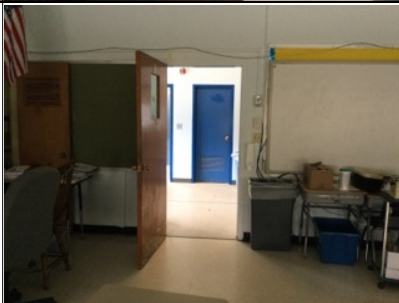
Maneuvering clearance(s) not provided Hardware not operable with a closed fist	- -	Relocate trash can to maintain the maneuvering clearance at the door. Provide hardware that can be operable with one hand and not require tight grasping, pinching, or twisting of the wrist.	1	484	\$484

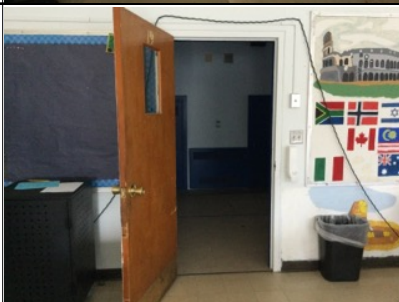
65	Grade 8/ History	1.5	19	Doors, Doorways, & Gates	Classroom

Hardware not operable with a closed fist	-	Provide hardware that can be operable with one hand and not require tight grasping, pinching, or twisting of the wrist.	1	484	\$484

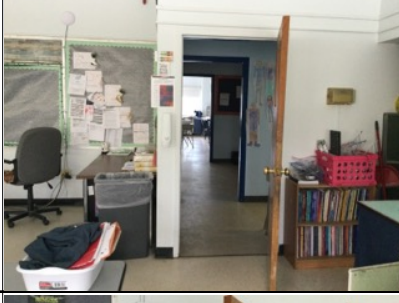
Hardware not operable with a closed fist	-	Provide hardware that can be operable with one hand and not require tight grasping, pinching, or twisting of the wrist.	1	484	\$484
68	Grade 7/ ELA	1.5	17	Doors, Doorways, & Gates	Classroom

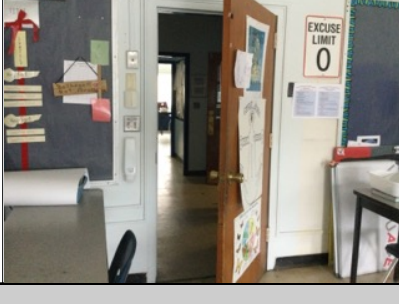
Hardware not operable with a closed fist	-	Provide hardware that can be operable with one hand and not require tight grasping, pinching, or twisting of the wrist.	1	484	\$484
<b>Stairways</b>												
69	Stair to Exit Near Lift Between Middle Wing and Junior High Wing From Gym	B		Stairways	Egress

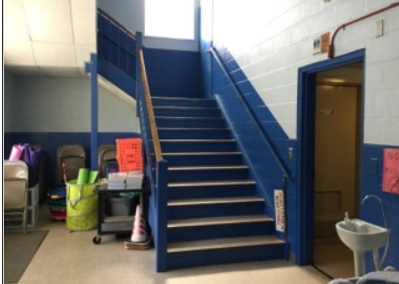
70	To Junior High Wing From Gym Entrance/ Exit	B		Stairways	Egress

Handrails not continuous where required	-	Provide continuous handrails.  Note: Recommendation applies to all stairs.	1	-	\$0

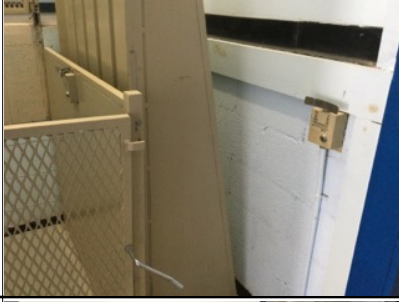
Not independently operable	-	Adjust controls to be independently operable or provide a new lift.	1	-	\$0

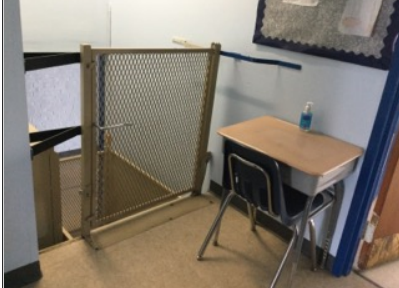
75	Lift Upper Level Near Grade 6/ Math	1		Platform Lift or LULA Elevator	Interior

Clear floor space not provide at lift		Relocate table to maintain the required clear floor space at the door of the lift.	1	-	\$0

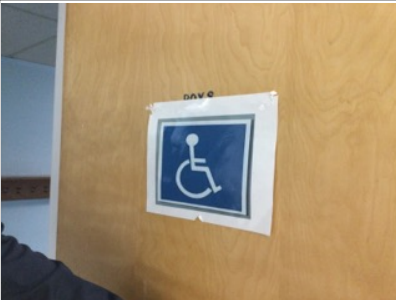
Sign not located on the latch side of the door	-	Locate a permanent International Symbol of Accessibility (ISA) alongside the door on the latch side.	1	Labor	\$0
78	Girls' Toilet Room	1		Signage	Designation

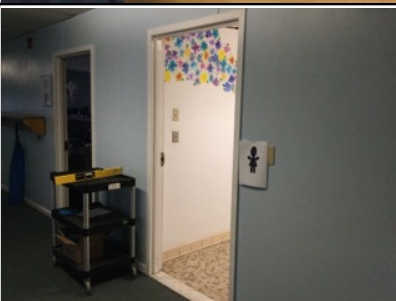
Raised characters not provided on sign Braille not provided on sign Sign not located on the latch side of the door	- - -	Provide text with raised characters duplicated in braille on sign. Locate sign at permanent rooms alongside the door on the latch side.	1	232	\$232

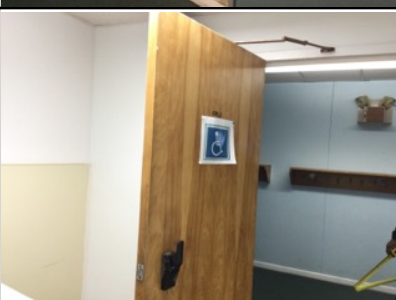
79	Girls' Toilet Room	1		Signage	Designation

Sign not located on the latch side of the door	-	Locate a permanent International Symbol of Accessibility (ISA) alongside the door on the latch side.	1	Labor	\$0
80	Grade 1	1	2	Signage	Designation

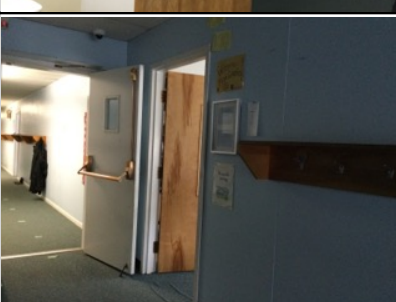
Raised characters not provided on sign Braille not provided on sign Sign not located on the latch side of the door	- - -	Provide text with raised characters duplicated in braille on sign. Locate sign alongside the door on the latch side.	1	232	\$232

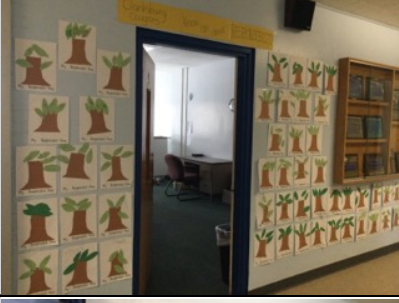
Raised characters not provided on sign Braille not provided on sign Sign not located on the latch side of the door	- - -	Provide text with raised characters duplicated in braille on sign. Locate sign alongside the door on the latch side.	1	232	\$232
83	Students Accessible Toilet Room	1		Signage	Designation

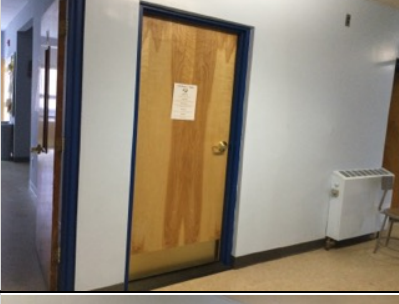
International Symbol of Acc. not provided	-	Provide a sign with the International Symbol of Accessibility (ISA).	1	232	\$232
84	Nurse's Office	1	11	Signage	Designation

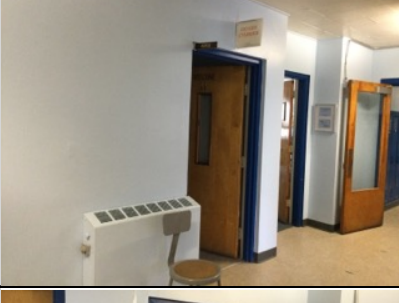
Raised characters not provided on sign Raised characters < 48" or > 60" above ground Braille not provided on sign	- - -	Provide text with raised characters duplicated in braille on sign. Mount sign so that the baseline of the lowest tactile character is 48" min. above finished floor and the baseline of the highest tactile character is 60" max. above the finished floor.	1	232	\$232

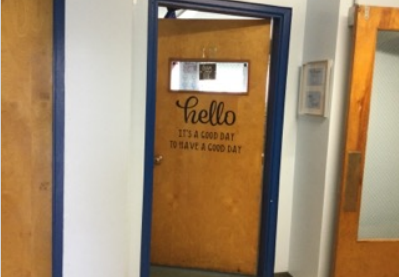
85	Grade 3	1	12	Signage	Designation

Raised characters not provided on sign Braille not provided on sign Sign not located on the latch side of the door	- - -	Provide text with raised characters duplicated in braille on sign. Locate sign alongside the door on the latch side.	1	232	\$232

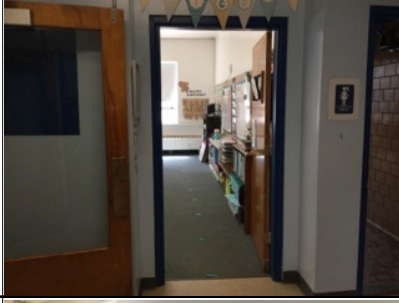
Raised characters not provided on sign Braille not provided on sign Sign not located on the latch side of the door	- - -	Provide text with raised characters duplicated in braille on sign. Locate sign alongside the door on the latch side.	1	232	\$232
88	Girls' Toilet Room - Near Room #13	1		Signage	Designation

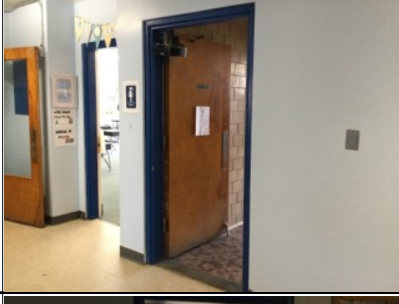
Raised characters not provided on sign Braille not provided on sign Sign not located on the latch side of the door Directional sign to access. toilet not provided	- - - -	Provide text with raised characters duplicated in braille on sign. Locate sign alongside the door on the latch side. Install a sign indicating the location of the nearest accessible toilet room.	2	232	\$464

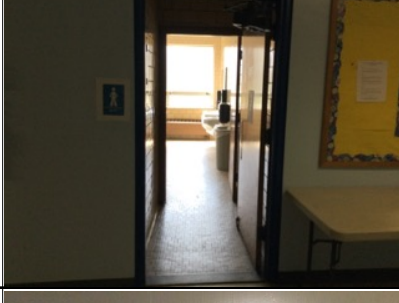
89	Boys' Toilet Room - Near Room #13	1		Signage	Designation

Raised characters not provided on sign Braille not provided on sign Directional sign to access. toilet not provided	- - -	Provide text with raised characters duplicated in braille on sign. Install a sign indicating the location of the nearest accessible toilet room.	2	232	\$464
90	Men's Toilet Room	B		Signage	Designation

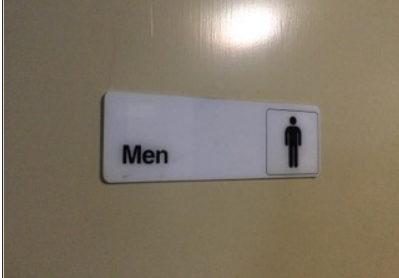
Raised characters not provided on sign Braille not provided on sign Sign not located on the latch side of the door	- - -	Provide text with raised characters duplicated in braille on sign. Locate sign alongside the door on the latch side.	1	232	\$232

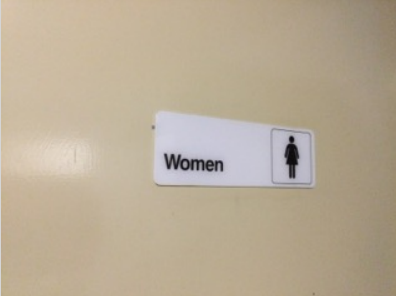
Raised characters not provided on sign Braille not provided on sign Sign not located on the latch side of the door	- - -	Provide text with raised characters duplicated in braille on sign. Locate sign alongside the door on the latch side.	1	232	\$232
92	Grade 6/ Science	1.5	18	Signage	Designation

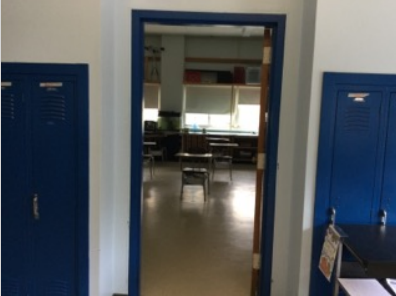
Raised characters not provided on sign Braille not provided on sign Sign not located on the latch side of the door	- - -	Provide text with raised characters duplicated in braille on sign. Locate sign alongside the door on the latch side.	1	232	\$232
93	Grade 8/ History	1.5	19	Signage	Designation

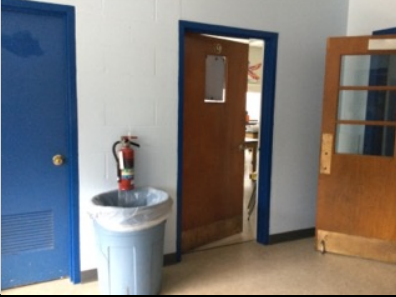
Raised characters not provided on sign Braille not provided on sign Sign not located on the latch side of the door	- - -	Provide text with raised characters duplicated in braille on sign. Locate sign alongside the door on the latch side.	1	232	\$232

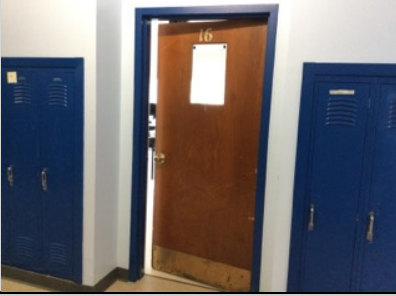
94	Grade 6/ Math	1.5	16	Signage	Designation

Raised characters not provided on sign Braille not provided on sign Sign not located on the latch side of the door	- - -	Provide text with raised characters duplicated in braille on sign. Locate sign alongside the door on the latch side.	1	232	\$232
<b>Operable Parts</b>												
95	OT/PT/ Special Ed	1		Operable Parts	Clothes Rod/Hooks

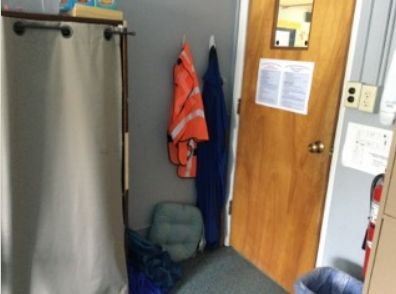
Reach < 15" or > 48"(forward/side approach)	57.5"	Locate at least one of the coat hooks 48" max. above the finished floor.	1	Labor	\$0

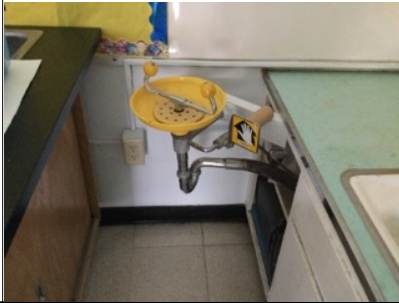
Element not on an accessible route	-	Ensure emergency eyewash is located on an accessible route.	1	-	\$0
<b>Dining or Work Surfaces</b>												
98	OT/PT/ Special Ed	1		Dining or Work Surfaces	Work Surface

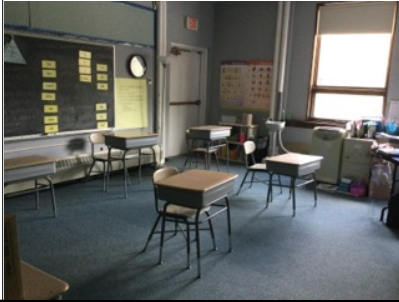
Knee or toe clearance not provided Top of dining/work surface < 26" or > 30"	18" 23"	Adjust at least one work surface to ensure a 24" min. knee and toe clearance is provided. Ensure at least one work surface is mounted between 26"- 30" above the floor.	1	Labor	\$0
99	Grade 2	1		Dining or Work Surfaces	Work Surface

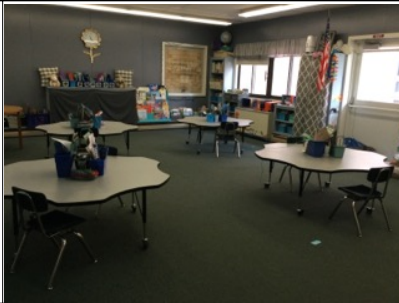
Knee or toe clearance not provided Top of dining/work surface < 26" or > 30"	21" 22"	Adjust at least one work surface to ensure a 24" min. knee and toe clearance is provided. Ensure at least one work surface is mounted between 26"- 30" above the floor.	1	Labor	\$0

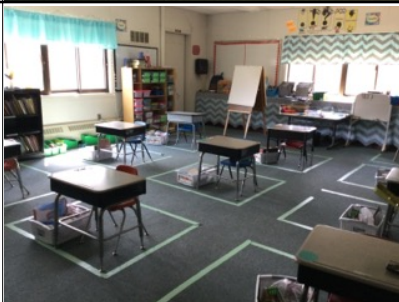
100	Grade 1	1	2	Dining or Work Surfaces	Work Surface

Knee or toe clearance not provided Top of dining/work surface < 26" or > 30"	17" 22.5"	Adjust at least one work surface to ensure a 24" min. knee and toe clearance is provided. Ensure at least one work surface is mounted between 26"- 30" above the floor.	1	Labor	\$0

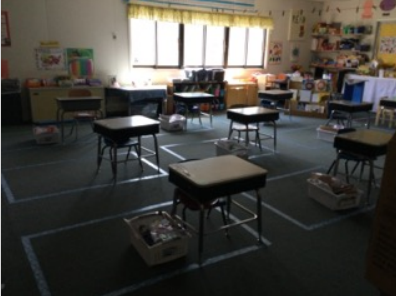
Knee or toe clearance not provided Top of dining/work surface < 26" or > 30"	18.5" 23"	Adjust at least one work surface to ensure a 24" min. knee and toe clearance is provided. Ensure at least one work surface is mounted between 26"- 30" above the floor.	1	Labor	\$0
102	Grade 2	1	6	Dining or Work Surfaces	Work Surface

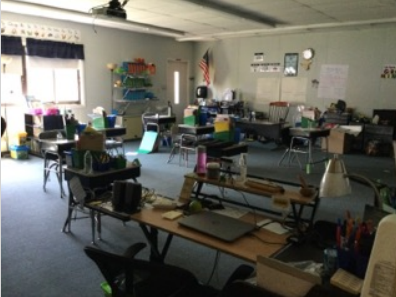
Knee or toe clearance not provided	22.25"	Adjust at least one work surface to ensure a 24" min. knee and toe clearance is provided.	1	Labor	\$0
103	Grade 3	1	12	Dining or Work Surfaces	Work Surface

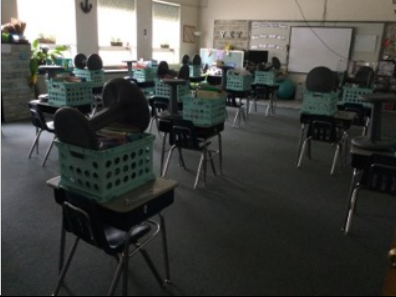
Knee or toe clearance not provided	22"	Adjust at least one work surface to ensure a 24" min. knee and toe clearance is provided.	1	Labor	\$0
104	Grade 4	1	14	Dining or Work Surfaces	Work Surface

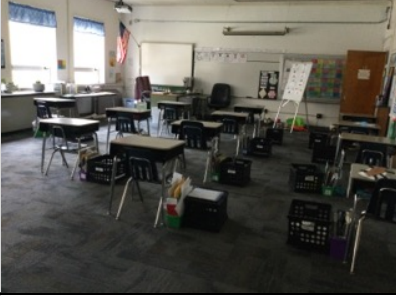
Knee or toe clearance not provided	23.5"	Adjust at least one work surface to ensure a 24" min. knee and toe clearance is provided. Ensure at least one work surface is mounted between 26"- 30" above the floor.	1	Labor	\$0

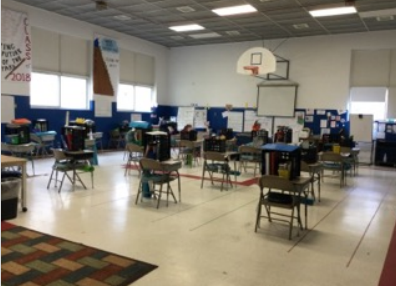
105	Gym - (Temporary Setup for Grade 5)	B		Dining or Work Surfaces	Work Surface

Knee or toe clearance not provided	22"	Adjust at least one work surface to ensure a 24" min. knee and toe clearance is provided.	1	Labor	\$0

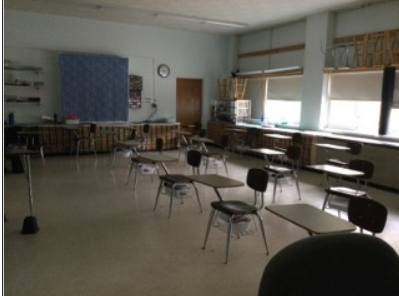
At least one or 5% accessible tables not provided	-	Provide at least one work surface with 24" min. knee and toe clearance. Ensure at least one work surface is mounted between 26"- 30" above the floor.	1	Labor	\$0
107	Grade 8/ History	1.5	19	Dining or Work Surfaces	Work Surface

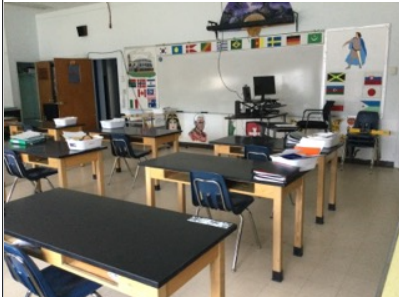
At least one or 5% accessible tables not provided Knee or toe clearance not provided	- 25"	Ensure that at least one work surface is accessible with 27" min. knee and toe clearance.	1	700	\$700
108	Grade 7/ ELA	1.5	17	Dining or Work Surfaces	Work Surface

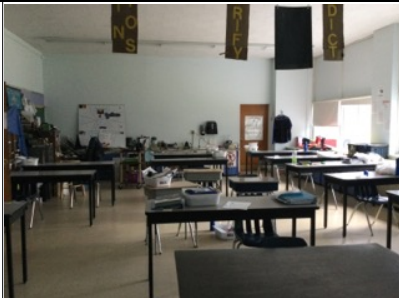
Knee or toe clearance not provided	25.5"	Provide at least 1 work surface with 27" min. knee and toe clearance.	1	700	\$700
<b>Lockers</b>												
109	Junior High Wing Hallway	1.5		Lockers	N/A

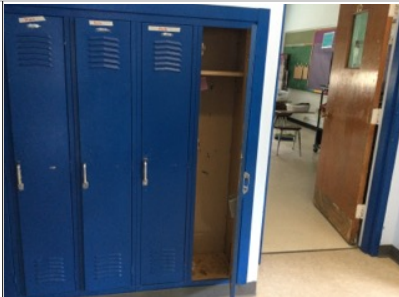
2% of lockers are not accessible Non-compliant hardware	- -	Provide at least 1 accessible locker (or ensure 2% of all lockers are accessible) . Provide hardware that can be operable with one hand and not require tight grasping, pinching, or twisting of the wrist.	1	660	\$660

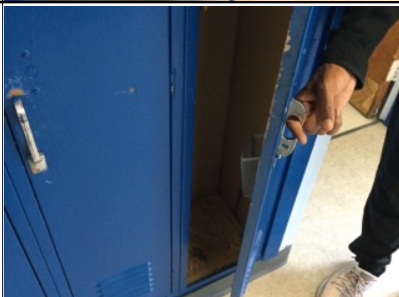
110	Junior High Wing Hallway	1.5		Lockers	N/A

- -	See ID #109 for recommendation.	1	-	\$0

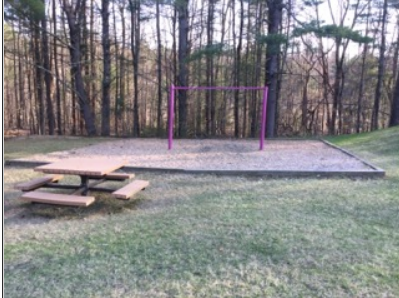
At least 5% accessible spaces not provided Picnic table not on an accessible route	- -	Ensure that at least 5% (minimum one) of picnic tables are accessible. Ensure that the picnic table is connected to an accessible route.  (See ID #142 for cost to provide an accessible route.)	1	1400	\$1400
112	Upper Level Open Space From Exits	Exterior		Picnic Tables	N/A

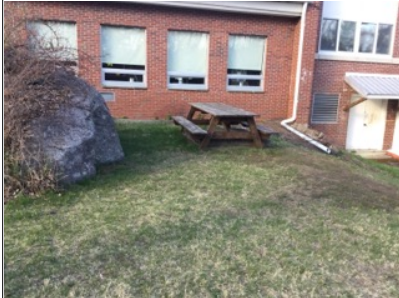
Picnic table not on an accessible route	-	Locate the picnic table so it is connected to an accessible route.	1	Labor	\$0
113	Outside Gym	Exterior		Picnic Tables	N/A

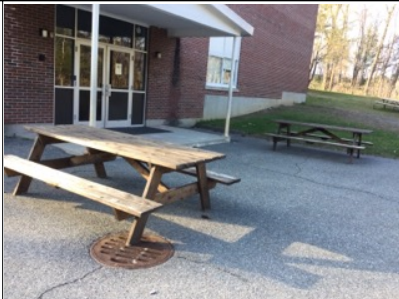
At least 5% accessible spaces not provided	-	Ensure that at least 5% (minimum one) of picnic tables are accessible.	1	1400	\$1400
<b>Toilet &amp; Bathing Rooms</b>												
<b>Overall Access</b>

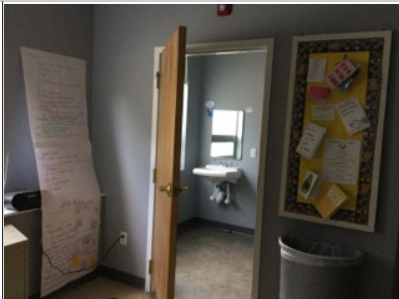
114	Single-User Toilet Room - Teachers Lounge	1	10	Overall Access	Toilet Room

International Symbol of Acc. not provided	-	Provide a sign with the International Symbol of Accessibility.	1	232	\$232
115	Single-User Toilet Room (Grade 8/History)	1.5	19	Overall Access	Toilet Room

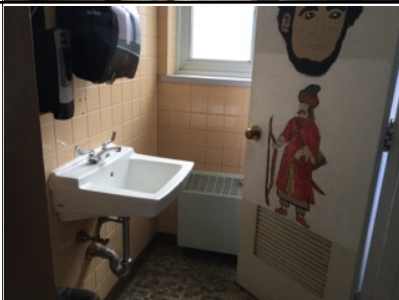
Sign to accessible toilet not provided		Provide a directional sign indicating the location of the nearest accessible toilet or bathing room.	1	232	\$232

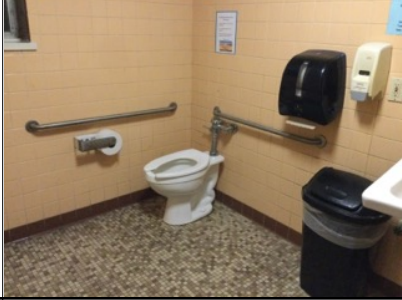
Flush control not on open side Paper towel dispenser is not compliant	- -	Relocate the flush control to the open side. Relocate paper towel dispenser so it is not mounted above the rear grab bar. Ensure dispensers and other devices are not mounted above grab bars.	1	727	\$727
118	Women's Toilet Room	B		Single-User Toilet	N/A

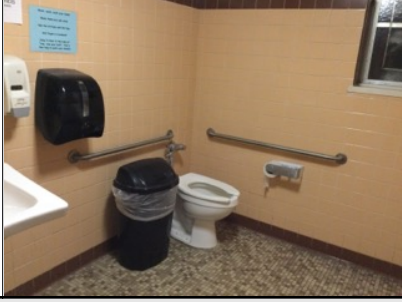
Paper towel dispenser is not compliant	-	Relocate paper towel dispenser so it is not mounted above the rear grab bar. Ensure dispensers and other devices are not mounted above grab bars.	1	353	\$353

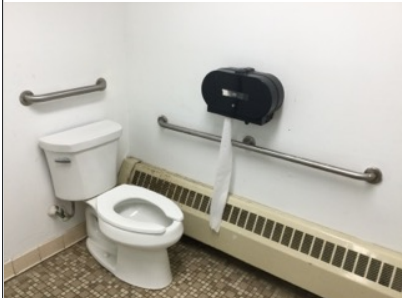
Side or rear grab bar < 42" long Non-compliant toilet paper dispenser	19" -	Provide a side grab bar that is 42" long located 6" max. from the interior corner. Relocate toilet paper dispenser so that it is between 14"- 19" above the floor and between 7"- 9" in front of the toilet. Ensure dispensers and other devices are not mounted above grab bars.	1	1154	\$1154

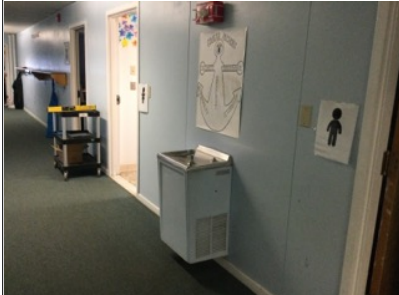
No drinking fountain provided for standing users No drinking fountain provided for seated users	- -	Provide a Hi-Lo drinking fountain.	1	4216	\$4216

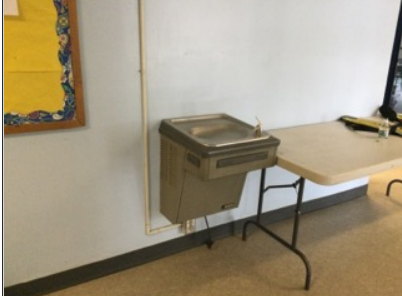
ID	Location	Floor	Room	Element	Type	Photo	Issues	Current Measure	Recommendations	Quantity	Price	Cost Estimation
125	Towards Middle Wing From Main Entrance	1		Drinking Fountains	Low

No drinking fountain provided for standing users	-	Provide an additional drinking fountain for standing users.	1	4028	\$4028
126	Near - Toilet Rooms Gym	B		Drinking Fountains	Low

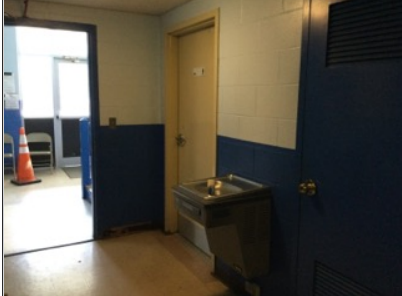
No drinking fountain provided for standing users	-	Provide an additional drinking fountain for standing users or install a Hi-Lo drinking fountain.	1	4028	\$4028
<b>Sink</b>												
127	Grade 2	1		Sink	Classroom

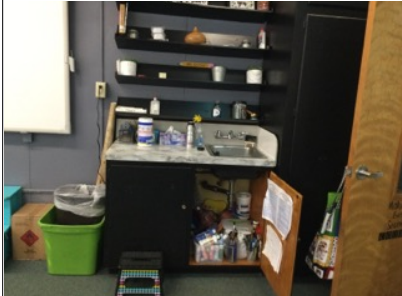
Toe and knee clearances not provided	-	Ensure there is a 27" knee clearance positioned for a forward approach.	1	1686	\$1686
128	Nurse's Office	1	11	Sink	N/A

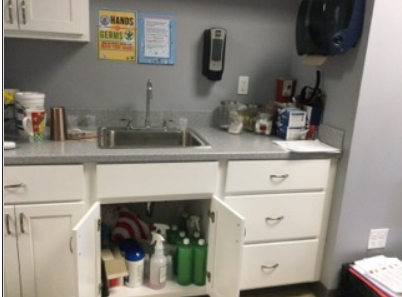
If students are allow to use this sink, make sure that there is a clear floor space position for a forward approach.	1	-	\$0
129	Grade 3	1	12	Sink	Classroom

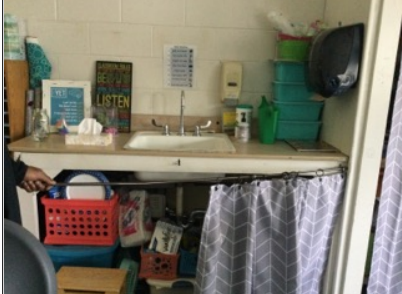
Toe and knee clearances not provided Exposed plumbing underneath sink	- -	Relocate storage to ensure the required 27" knee clearance positioned for a forward approach at the sink. Insulate or otherwise configure pipes at sink.	1	92	\$92

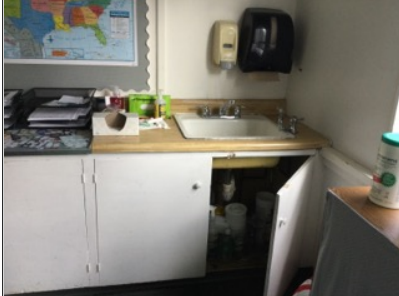
ID	Location	Floor	Room	Element	Type	Photo	Issues	Current Measure	Recommendations	Quantity	Price	Cost Estimation
130	Grade 4	1	14	Sink	Classroom

Toe and knee clearances not provided	-	Ensure there is a 27" knee clearance positioned for a forward approach.	1	1686	\$1686
131	Grade 3	1	15	Sink	Classroom

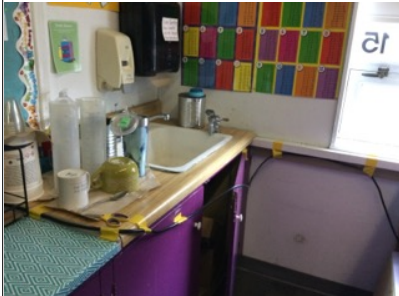
Clear floor space not provided at sink Toe and knee clearances not provided	-	Provide a 30" by 48" clear floor space positioned for a forward approach. Ensure there is a 27" knee clearance positioned for a forward approach.	1	1686	\$1686
132	Grade 5	1	13	Sink	Classroom

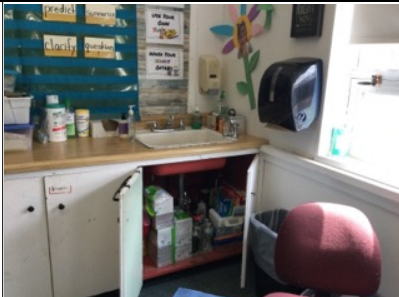
Toe and knee clearances not provided	-	Ensure there is a 27" knee clearance positioned for a forward approach.	1	1686	\$1686
133	Grade 6/ Science	1.5	18	Sink	Classroom

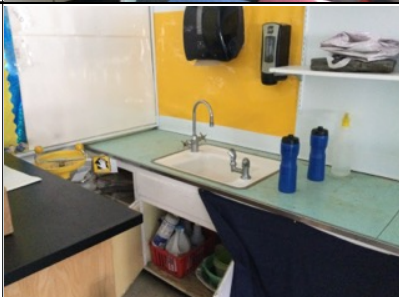
Clear floor space not provided at sink Toe and knee clearances not provided	- -	Provide a 30" by 48" clear floor space positioned for a forward approach. Ensure there is a 27" knee clearance positioned for a forward approach.	1	1686	\$1686

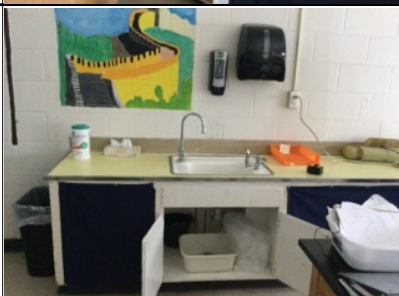
134	Grade 8/ History	1.5	19	Sink	Classroom

Toe and knee clearances not provided	-	Ensure there is a 27" knee clearance positioned for a forward approach.	1	1686	\$1686

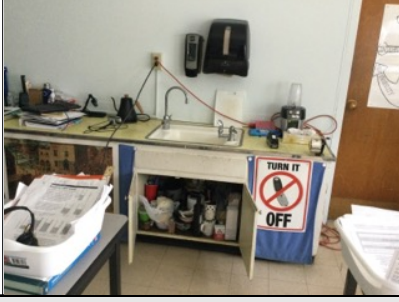
Toe and knee clearances not provided	-	Ensure there is a 27" knee clearance positioned for a forward approach.	1	1686	\$1686
<b>Play and Sport Areas</b>												
<b>Play Areas</b>												
137	Play Set 1	Ext.		Play Areas	N/A

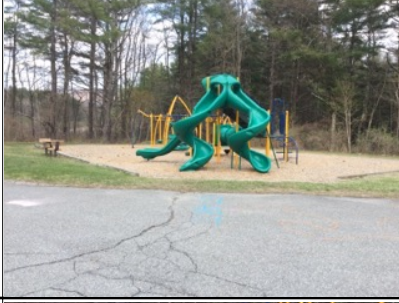
Accessible route not provided to play components Surface not stable, firm, and slip-resistant	- -	Provide a compliant impact-attenuating surface to and around the play components. Ensure that surface is firm, stable and slip-resistant (to areas around play components).  (Cost for poured-in-place rubber surface.)	1	21000	\$21000
138	Play Set 1	Ext.		Play Areas	N/A

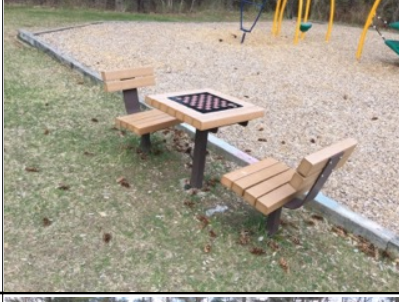
Accessible route not provided to playground	-	Ensure an accessible route is provided to table.  (See ID #139 for cost.)	1	-	\$0

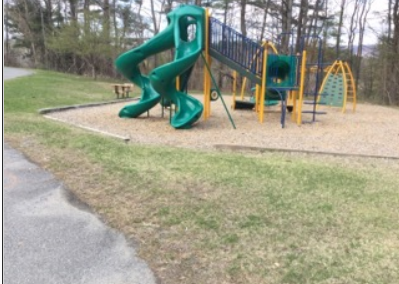
139	Play Set 1	Ext.		Play Areas	N/A

Accessible route not provided to playground Accessible route not provided around playground	- -	Install an accessible route to and around the playground.  (Cost estimate for 242 ft. long by 4 ft. wide stone dust.)	1	7744	\$7744

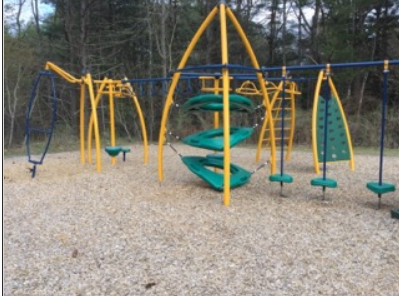
ID	Location	Floor	Room	Element	Type	Photo	Issues	Current Measure	Recommendations	Quantity	Price	Cost Estimation
140	Play Set 1	Exterior		Play Areas	N/A

Accessible route not provided to play components Surface not stable, firm, and slip-resistant	- -	Provide a compliant impact-attenuating surface to and around the play components. Ensure that surface is firm, stable and slip-resistant (to areas around play components).  (See ID #137 for cost.)	1	-	\$0
141	Play Set 1	Exterior		Play Areas	N/A

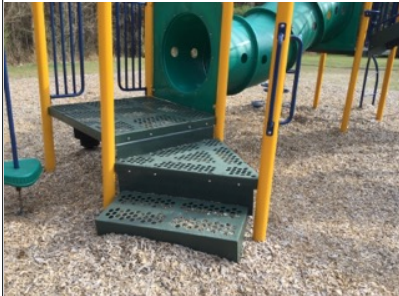
No compliant transfer system	-	Alteration might be technically infeasible.	1	-	\$0
142	To Swings	Ext.		Play Areas	N/A

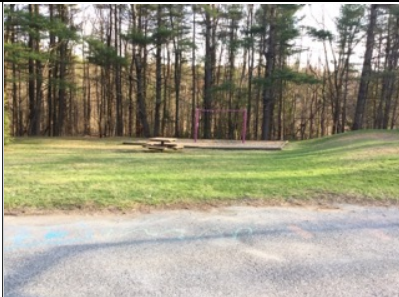
Accessible route not provided to playground Accessible route not provided around playground Accessible route not provided to play components	- - -	Install an accessible route to and around the playground. Provide a compliant impact-attenuating surface to and around the play components.	1	7894	\$7894

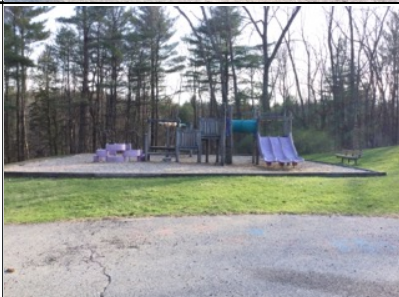
143	Play Set 2	Exterior		Play Areas	N/A

Accessible route not provided to playground Accessible route not provided around playground	- -	Install an accessible route to and around the playground. Provide an accessible route around the play area.  (Cost estimate for 199 ft. long by 4 ft. wide stone dust.)	1	6368	\$6368
144		Exterior		Play Areas	N/A

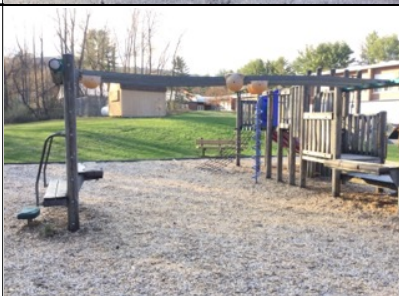
Accessible route not provided to play components Surface not stable, firm, and slip-resistant	- -	Provide a compliant impact-attenuating surface to and around the play components. Ensure surface is firm, stable and slip-resistant (to areas around play components).  (Cost for poured-in-place rubber surface)	1	16800	\$16800

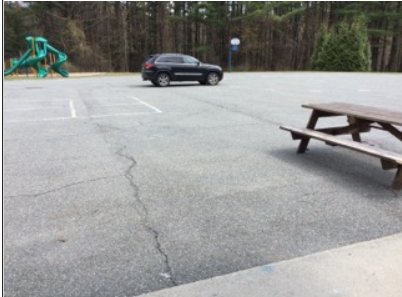
Recommend providing an accessible van parking space in this area.	1	-	\$0

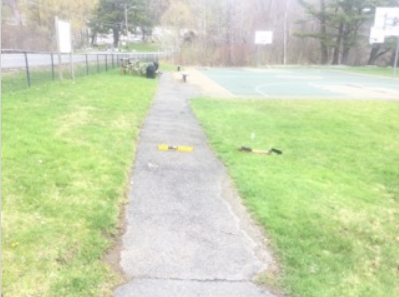
ID	Location	Floor	Room	Element	Type	Photo	Issues	Current Measure	Recommendations	Quantity	Price	Cost Estimation
<b>Approach and Entrance</b>												
<b>Exterior Access Route</b>												
1	Path to Basketball Court	Exterior		Exterior Access Route	Exterior

Cross slope > 1:50 (2.00%)	10.3%	Reduce cross slope to be no steeper than 1:50 (2.00%).  (See ID #6 for cost.)	1	-	\$0
2	Path to Basketball Court	Exterior		Exterior Access Route	Exterior

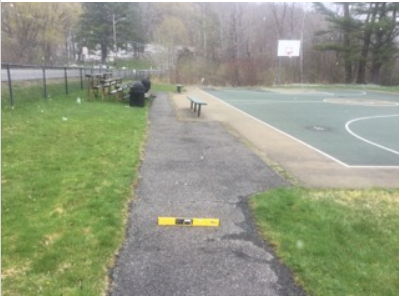
Cross slope > 1:50 (2.00%)	5.9%	Reduce cross slope to be no steeper than 1:50 (2.00%).  (See ID #6 for cost.)	1	-	\$0
3	Basketball Court	Exterior		Exterior Access Route	Exterior

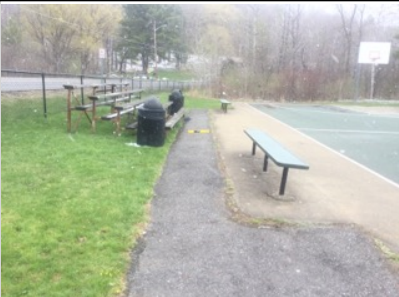
Cross slope > 1:50 (2.00%)	4.9	Reduce cross slope to be no steeper than 1:50 (2.00%).  (See ID #6 for cost.)	1	-	\$0
4	Bridge Near Pavilion	Exterior		Exterior Access Route	Exterior

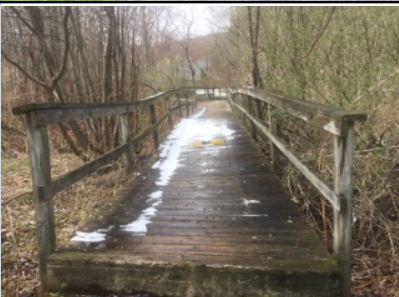
Cross slope > 1:50 (2.00%)	8.3%	Reduce cross slope to be no steeper than 1:50 (2.00%).	1	-	\$0

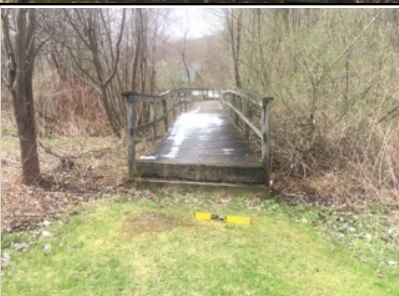
5	Bridge Near Pavilion	Exterior		Exterior Access Route	Exterior

Cross slope > 1:50 (2.00%) Level changes > 1/4"	5.4% 5"	Reduce cross slope to be no steeper than 1:50 (2.00%). Alter change in level to be 1/4" high max.	1	-	\$0

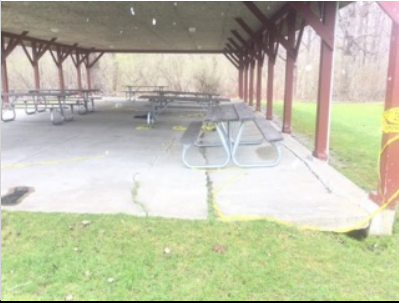
Level changes > 1/4"	0.5"	When renovation occurs, ensure change in level is 1/4" high max.	1	-	\$0
8	Basketball Court	Exterior		Exterior Access Route	Exterior

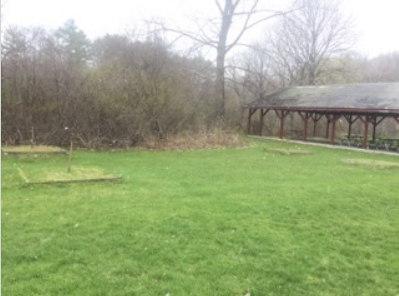
ID	Location	Floor	Room	Element	Type	Photo	Issues	Current Measure	Recommendations	Quantity	Price	Cost Estimation
11	Horseshoe Pits Near Pavilion	Exterior		Exterior Access Route	Exterior

Accessible route not provided	-	Ensure an accessible route is provided.  (See ID #13 for cost.)	1	-	\$0
12	Memorial Near Pavilion	Exterior		Exterior Access Route	Exterior

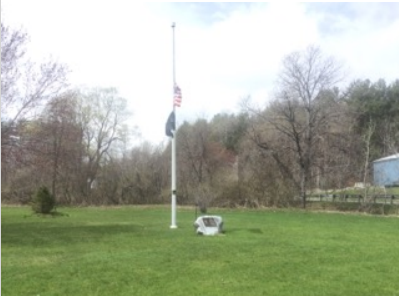
Accessible route not provided	-	Ensure an accessible route is provided.  (See ID #13 for cost.)	1	-	\$0
13	From Right Entry of Park Near Accessible Parking To Pavilion	Exterior		Exterior Access Route	Exterior

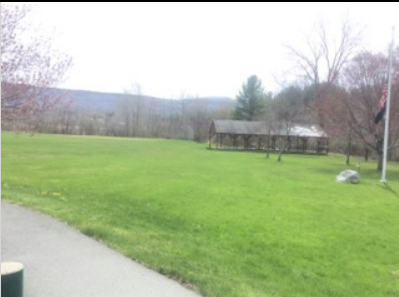
Accessible route not provided	-	Ensure an accessible route is provided to the memorial.	1	15360	\$15360
14	Trail Near Pavilion	Exterior		Exterior Access Route	Exterior

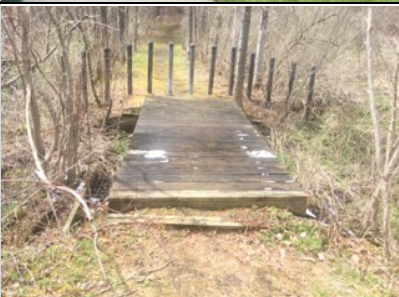
Accessible route not provided	-	Ensure an accessible route is provided.	1	-	\$0
15	Bridge Near Pavilion	Exterior		Exterior Access Route	Exterior

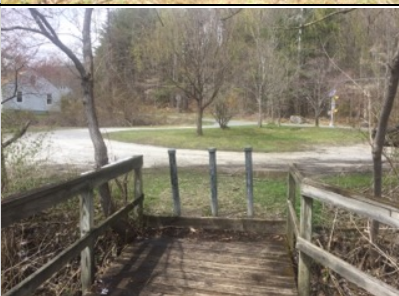
Accessible route not provided	-	Ensure an accessible route is provided.  See ID #25 for additional recommendations.	1	-	\$0

Recommend providing a sign at the beginning of the path letting members of the public know that there is not an accessible route at the end of the path.	1	-	\$0

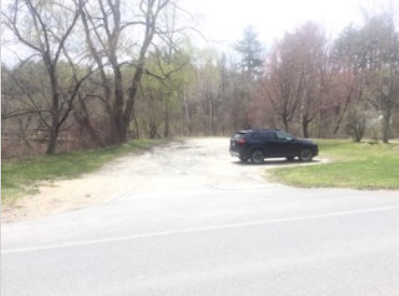
ID	Location	Floor	Room	Element	Type	Photo	Issues	Current Measure	Recommendations	Quantity	Price	Cost Estimation
<b>Off-Street Parking Lot or Garage</b>												
16	Parking Near Park, Left Entry	Exterior		Off-Street Parking Lot or Garage	Visitor

Total # of designated van accessible spaces	-	Provide a van accessible spaces that is at least 96" wide with a marked access aisle that is at least 96" wide. Locate sign with the bottom of the sign 60" above the ground and the top 96" max. above the ground. Add the designation "Van Accessible" to the sign.	1	800	\$800
17	Accessible Parking Spot	Exterior		Off-Street Parking Lot or Garage	Visitor

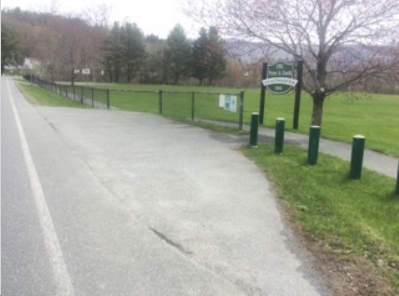
Total # of designated van accessible spaces Sign bottom < 60" above finished grade	- 23"	Provide a van accessible spaces that is at least 96" wide with a marked access aisle that is at least 96" wide. Locate sign with the bottom of the sign 60" above the ground and the top 96" max. above the ground. Add the designation "Van Accessible" to the sign.	1	800	\$800

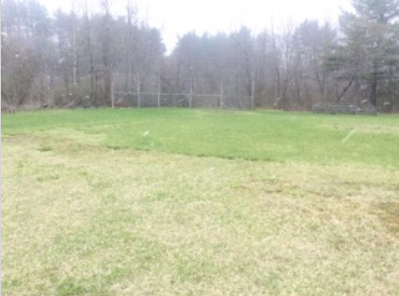
<b>Play and Sport Areas</b>												
<b>Field</b>												
18	Baseball Field	Exterior		Field	Baseball

No accessible route to all areas of sport activity	-	Install an accessible route between all areas of sports activity.  (See ID #13 for cost)	1	-	\$0
19	Baseball Field	Exterior		Field	Baseball

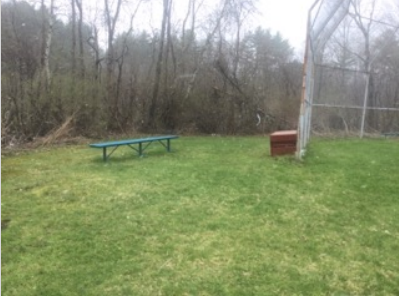
No accessible route to all areas of sport activity	-	Install an accessible route between all areas of sports activity.  (See ID #13 for cost)	1	-	\$0
20	Baseball	Exterior		Field	Baseball

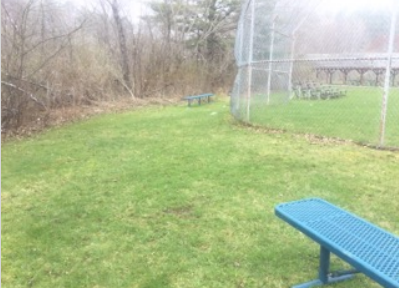
No accessible route to all areas of sport activity	-	Install an accessible route between all areas of sports activity.  (See ID #13 for cost.)	1	-	\$0

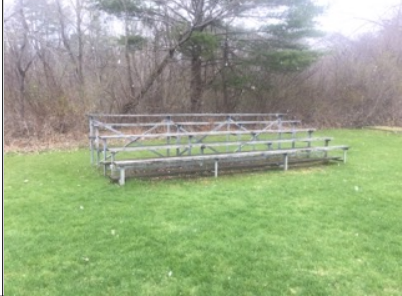
Accessible spaces are not provided at sidelines seating	-	Provide a 36" x 48" clear floor space at sidelines seating.  (See ID #13 for cost.)	1	-	\$0
<b>Best Practice</b>												
<b>Gate</b>												
23	To Basketball Court From Accessible Parking Spot	Exterior		Gate	N/A

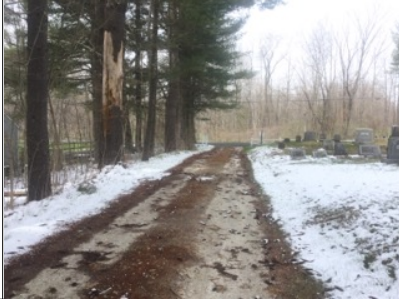
ID	Location	Floor	Room	Element	Type	Photo	Issues	Current Measure	Recommendations	Quantity	Price	Cost Estimation
<b>Approach and Entrance</b>												
<b>Exterior Access Route</b>												
1	From Back Path of Cemetery to Right Entry	Exterior		Exterior Access Route	Exterior

Surface is not stable, firm, and slip-resistant	-	Repair surface.	1	Labor	\$0
2	Left Entry (Near Shed)	Exterior		Exterior Access Route	Exterior

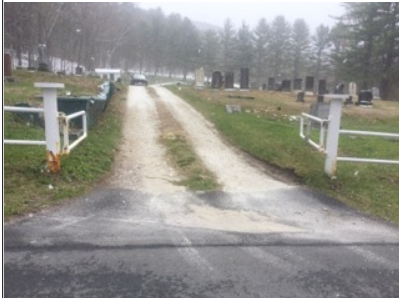
Surface is not stable, firm, and slip-resistant Route not maintained in operable working condition	- -	Ensure the accessible route is maintained in operable working condition.	1	Labor	\$0
3	From Back Path of Cemetery to Right Entry	Exterior		Exterior Access Route

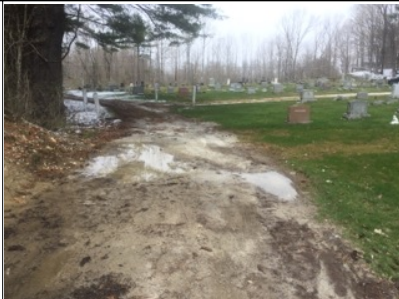
Surface is not stable, firm, and slip-resistant Route not maintained in operable working condition	- -	Ensure the accessible route is maintained in operable working condition.	1	Labor	\$0
<b>Access to Goods and Services</b>

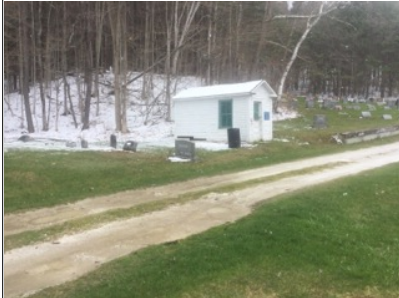
<b>Trash / Recycling</b>												
4	Near Shed	Exterior		Trash / Recycling	N/A

Trash container not connected to an accessible route	-	Ensure trash container is located on an accessible route.	1	Labor	\$0
<b>Best Practice</b>

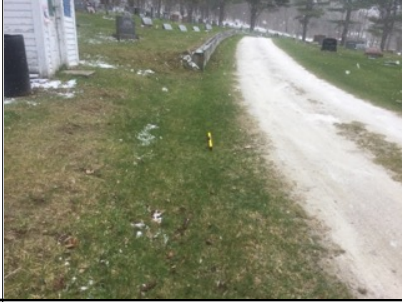
ID	Location	Floor	Room	Element	Type	Photo	Issues	Current Measure	Recommendations	Quantity	Price	Cost Estimation
<b>Bench</b>												
5	Near Shed to Back Path of Cemetery	Exterior		Bench	N/A

Recommend providing a bench with back and armrest here.	1	-	\$0
6	From Back Path of Cemetery to Right Entry	Exterior		Bench	N/A

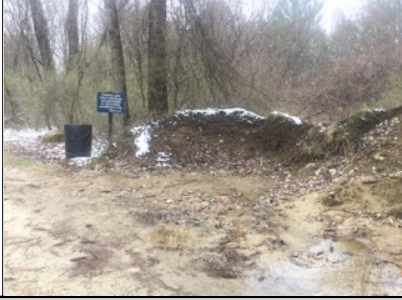
Recommend providing a bench with back and armrest here.	1	-	\$0
<b>Signage</b>												
7	Left Entry (Near Shed)	Exterior		Signage	N/A

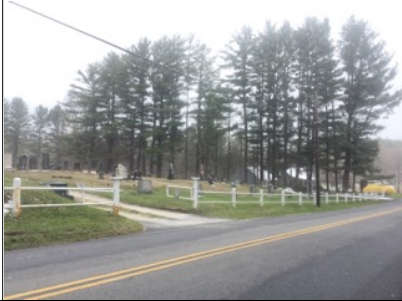
Recommend providing a sign here with the cemetery information.	1	-	\$0
8	Shed	Exterior		Signage	N/A

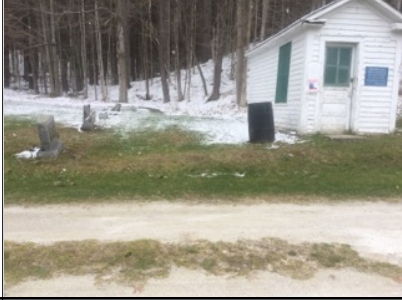
Recommend providing a sign with information on who to contact for information.	1	-	\$0
9	Back Path of Cemetery	Exterior		Signage	N/A

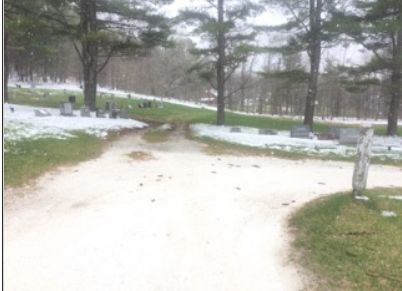
Recommend providing directional signage at intersections.	1	-	\$0
