## Town of Clarksburg, Massachusetts

## Municipal Buildings

# Town Hall

## Town of Clarksburg ADA Transition Plan

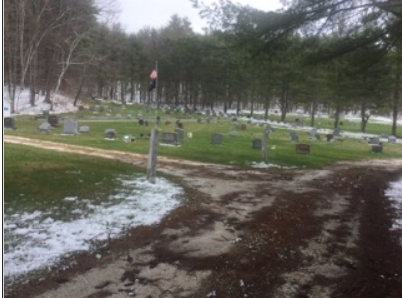
ID	Location	Floor	Room	Element	Type	Photo	Issues	Current Measure	Recommendations	Quantity	Price	Cost Estimation
10	Memorial (Near Middle Path)	Exterior		Signage	N/A

Recommend providing a wayside here with information about the memorial.	1	-	\$0
